Progress Report for SE WI Fox River Commission

Mill Creek Drainageway Improvement

Grading Drainageway, Erosion Control

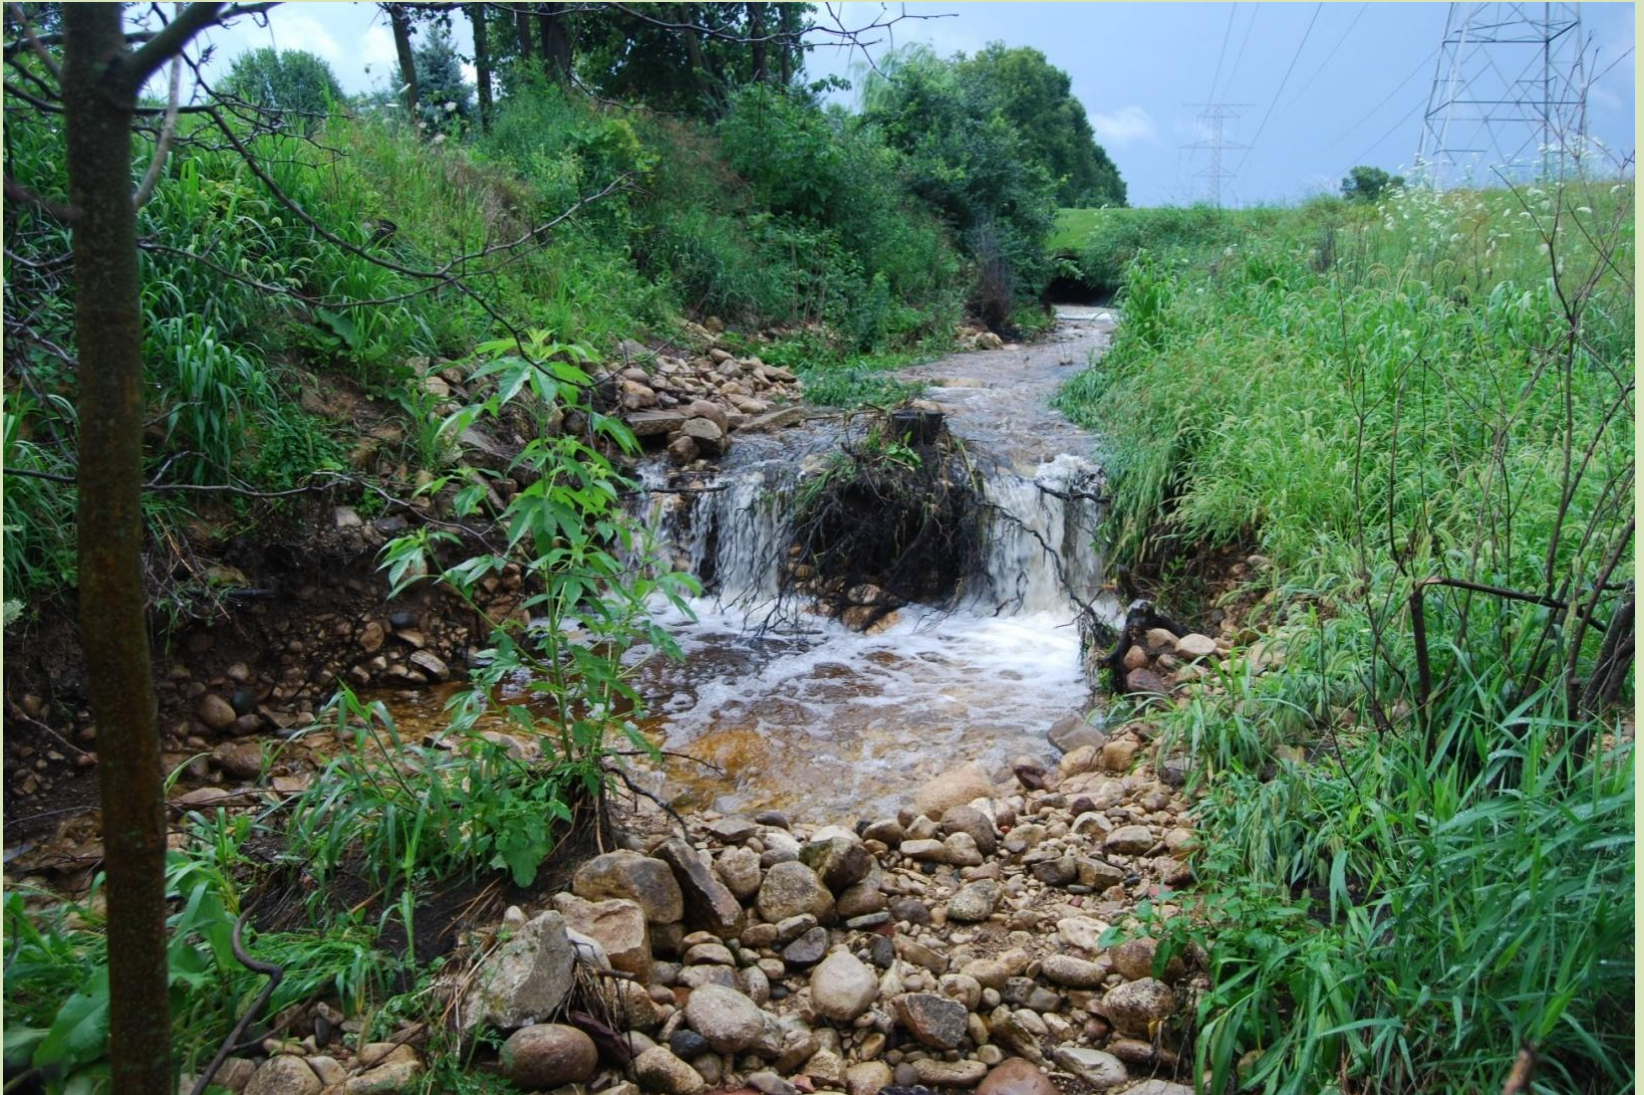
Eroded Material in Mill Creek Floodplain

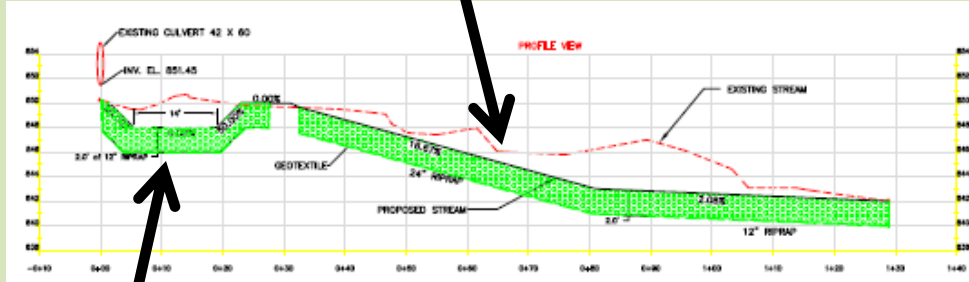
Stilling Basin

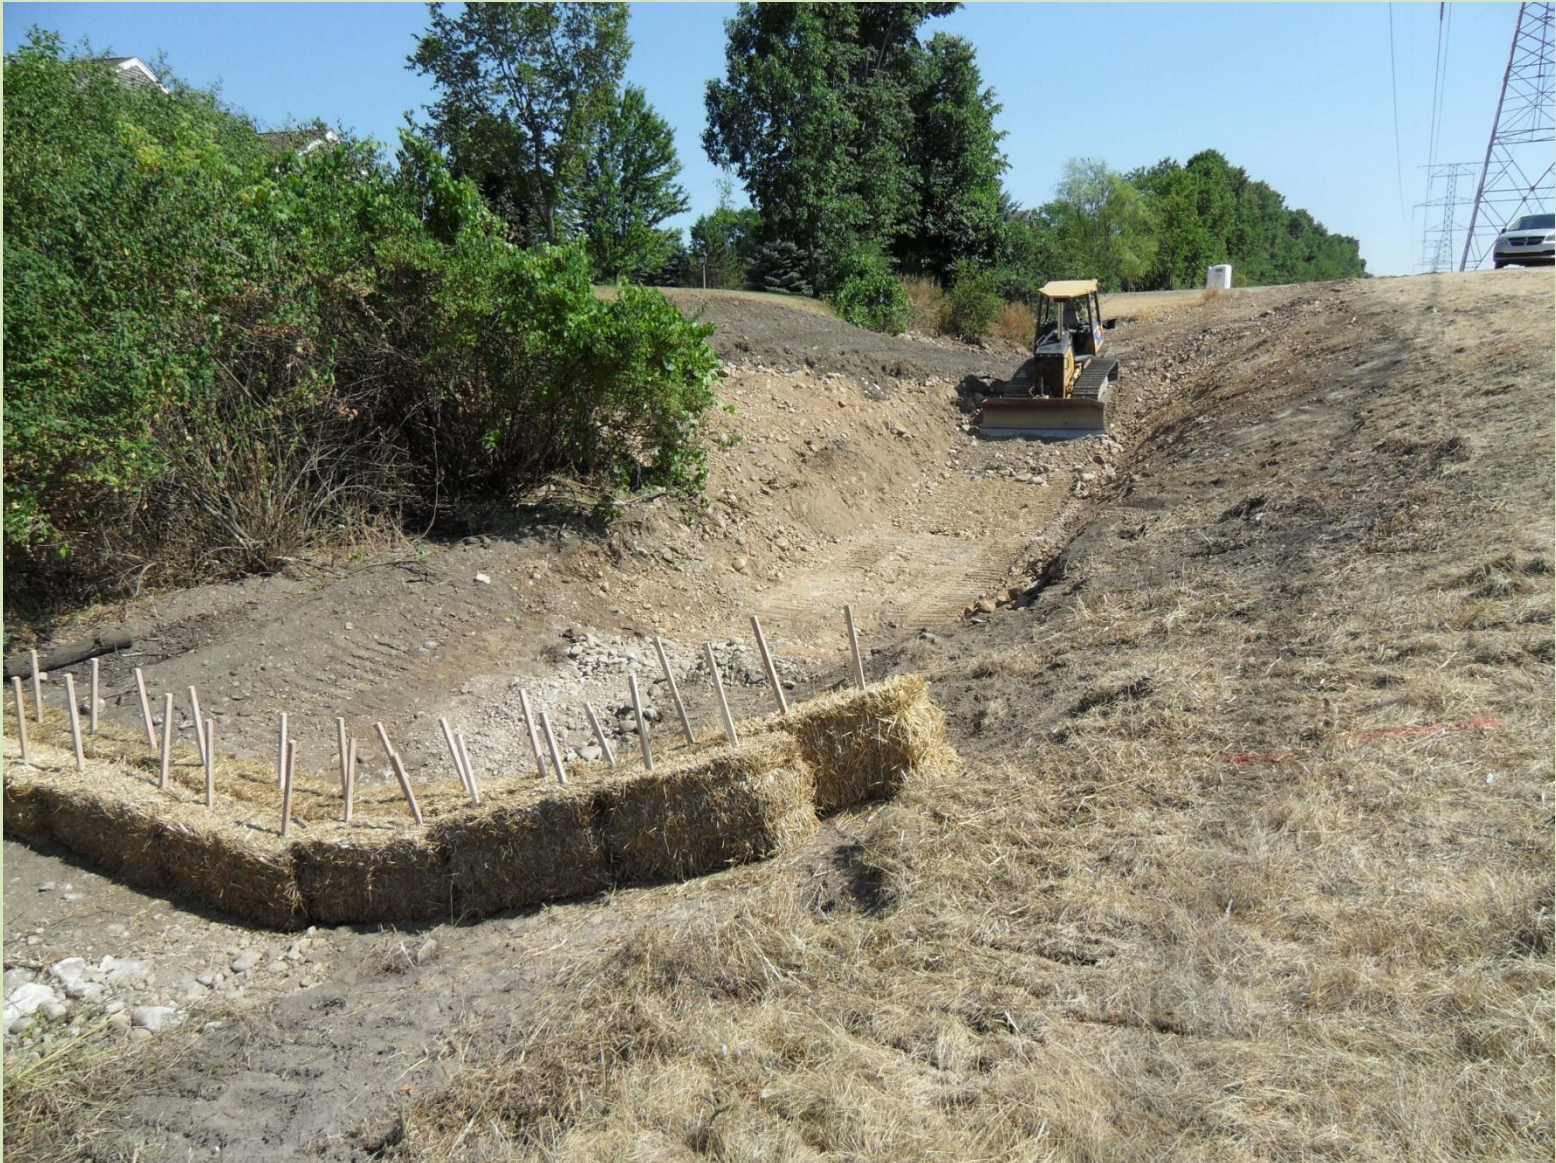
Over-Excavating Stilling Basin

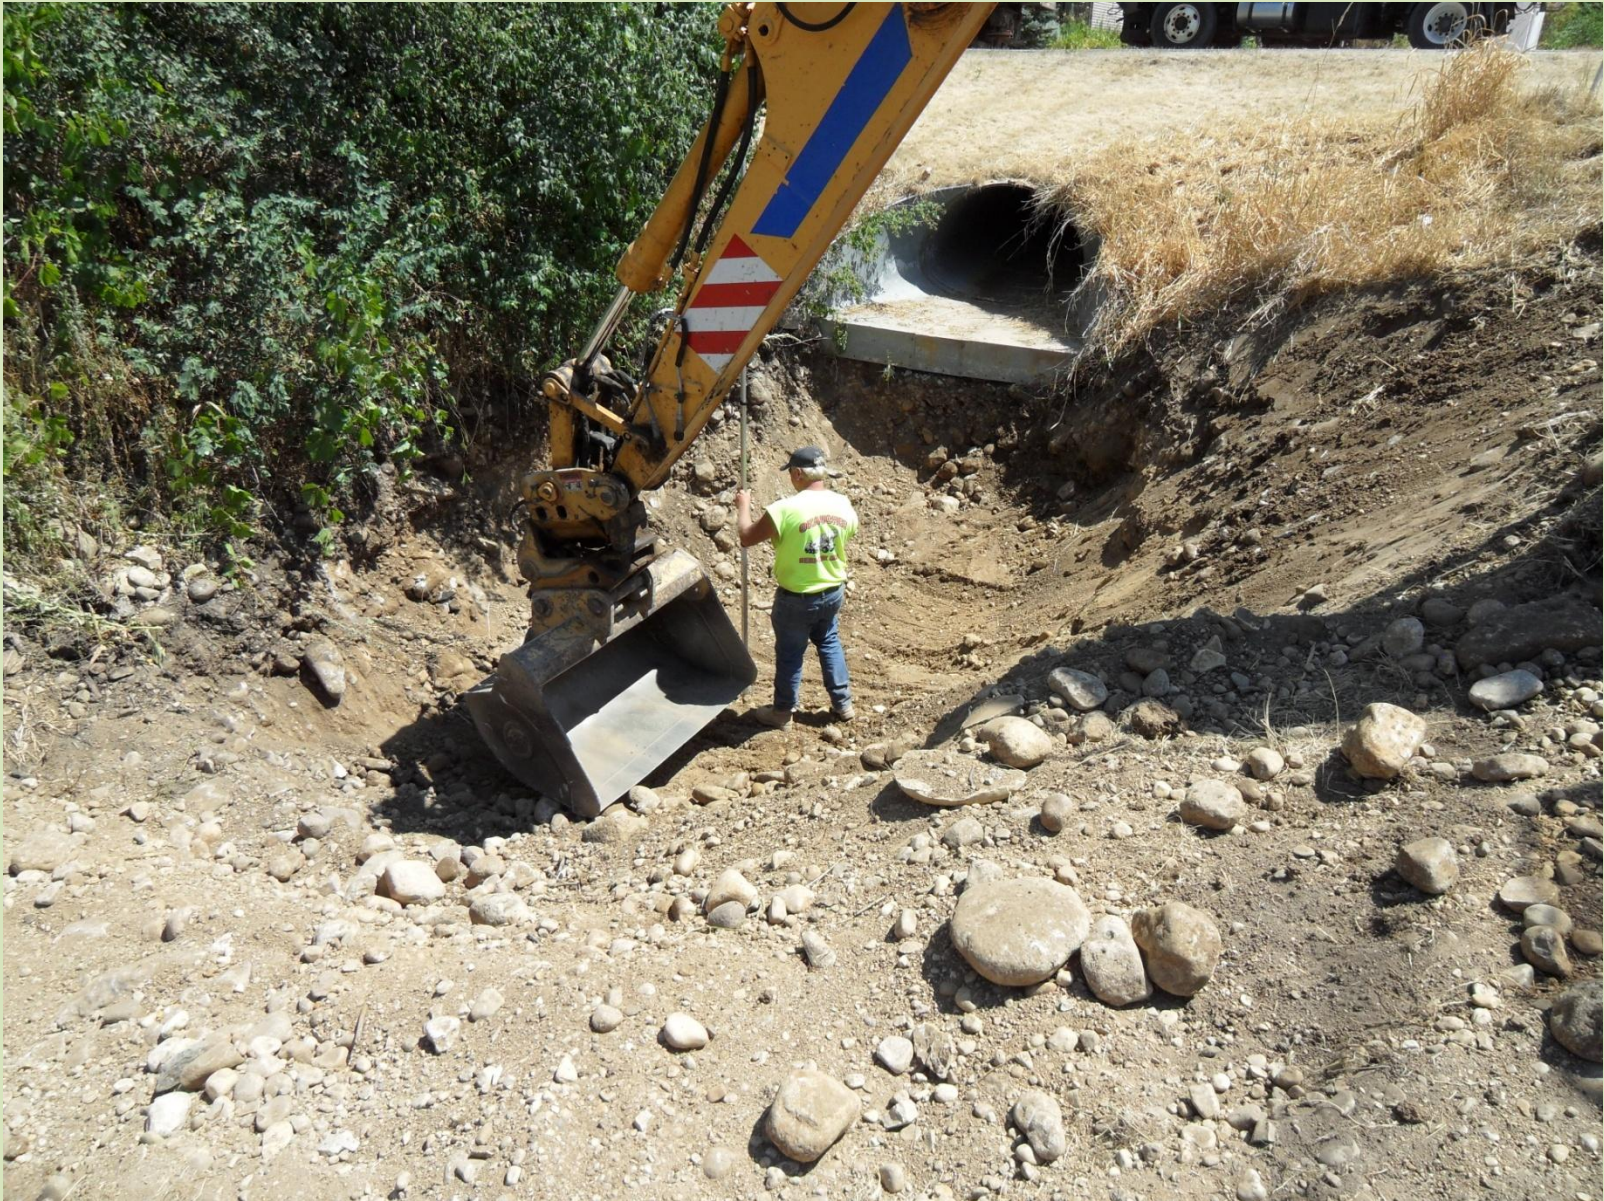
Most-Eroded Bank After Being Filled

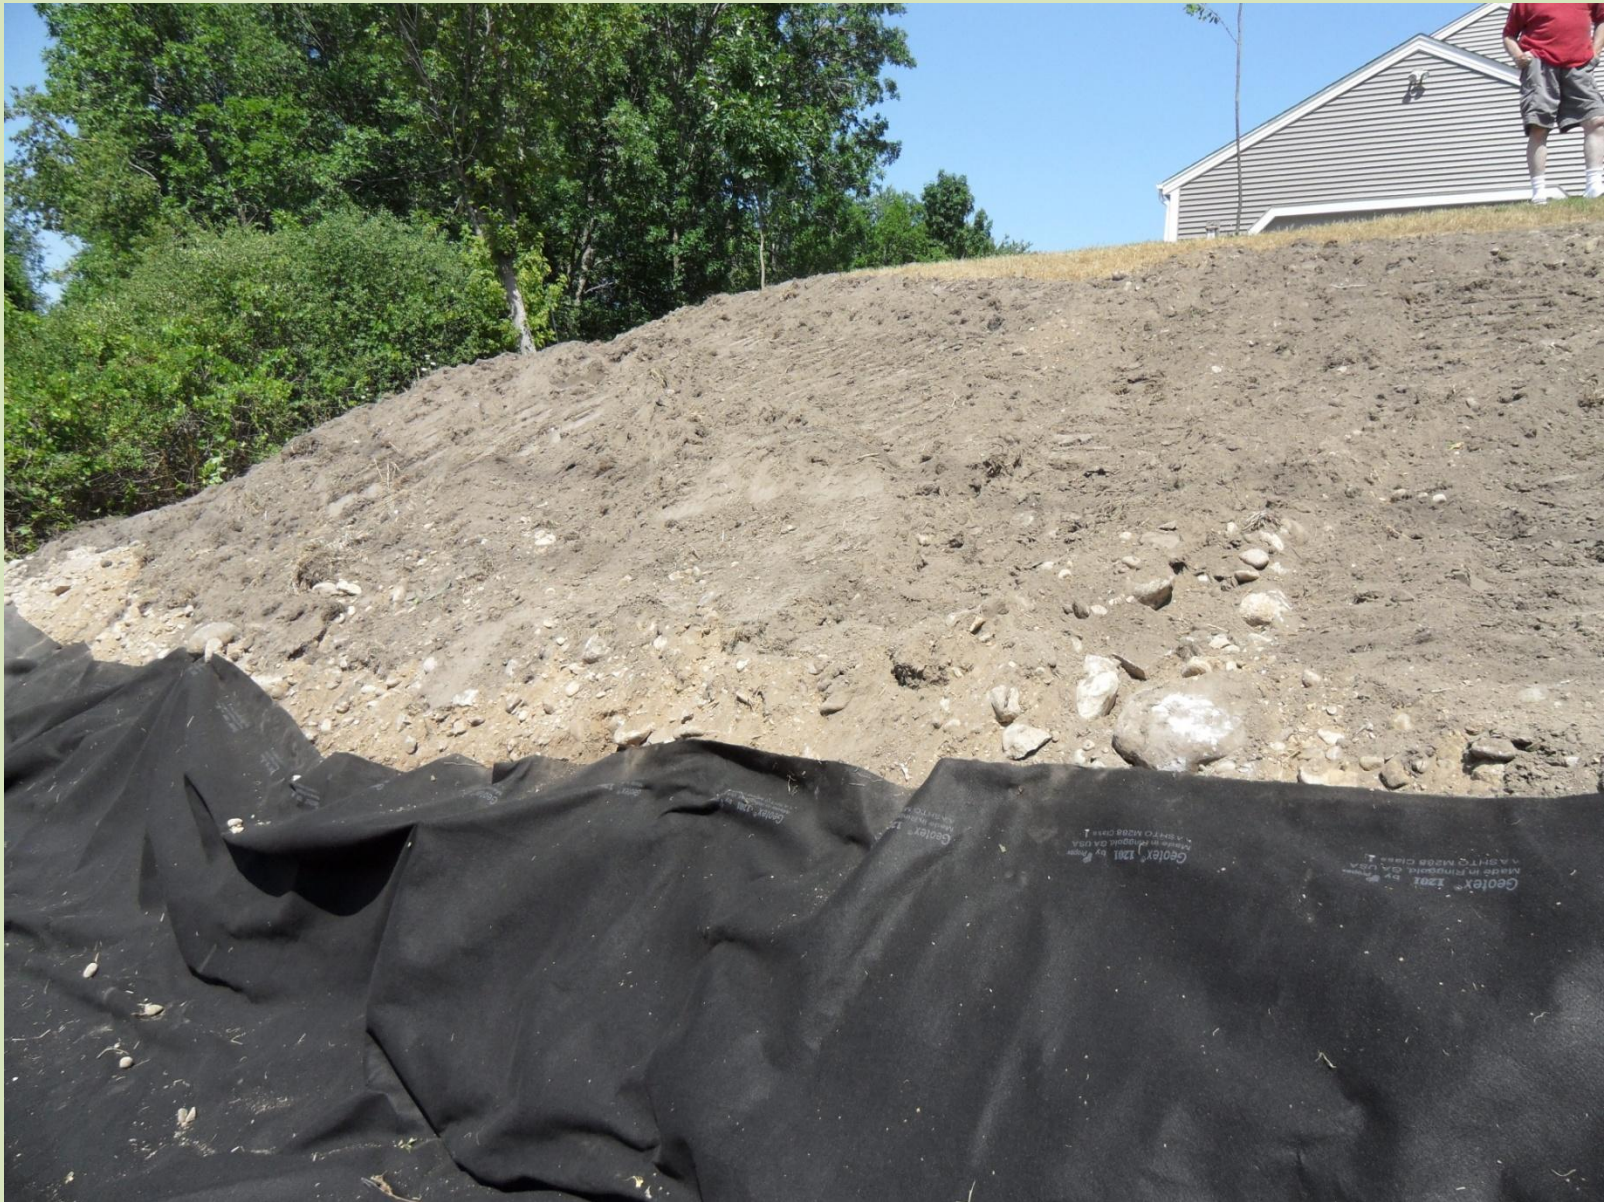
Geotextile Under Riprap

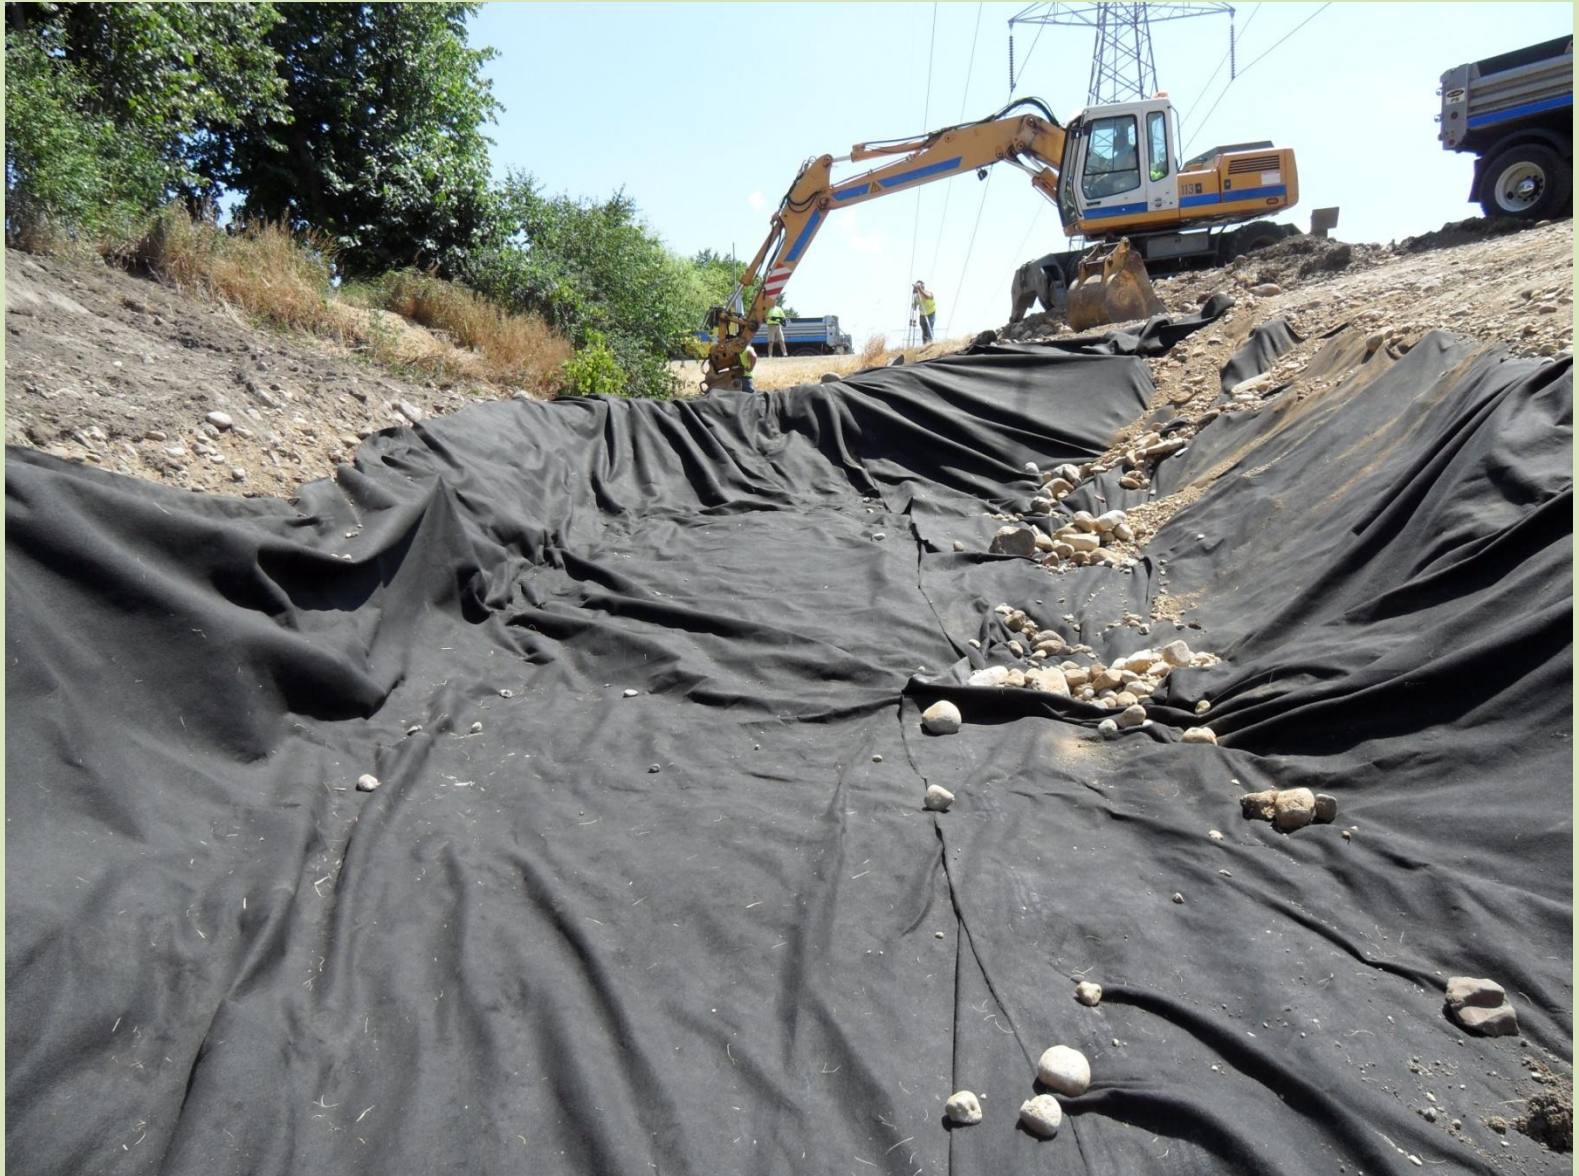
Placing 18-Inch Riprap

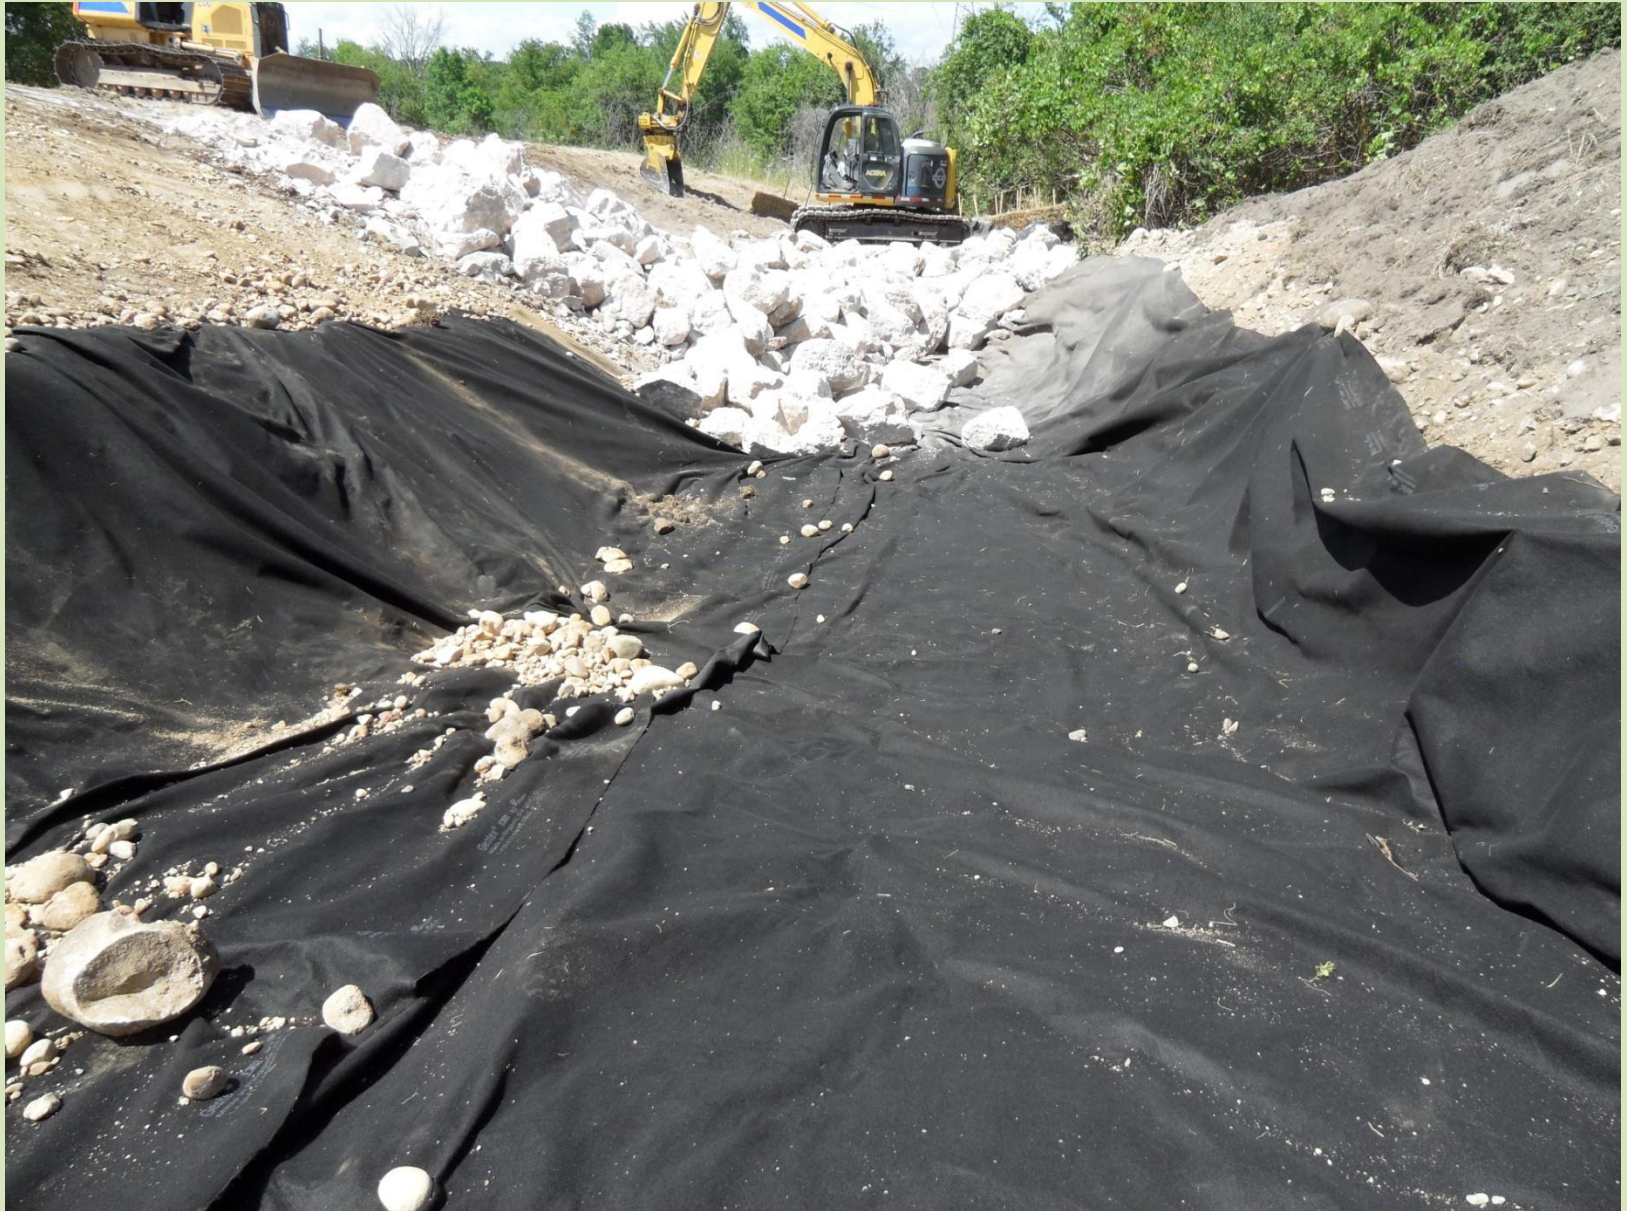
Riprap Delivery. Note Claw on Excavator

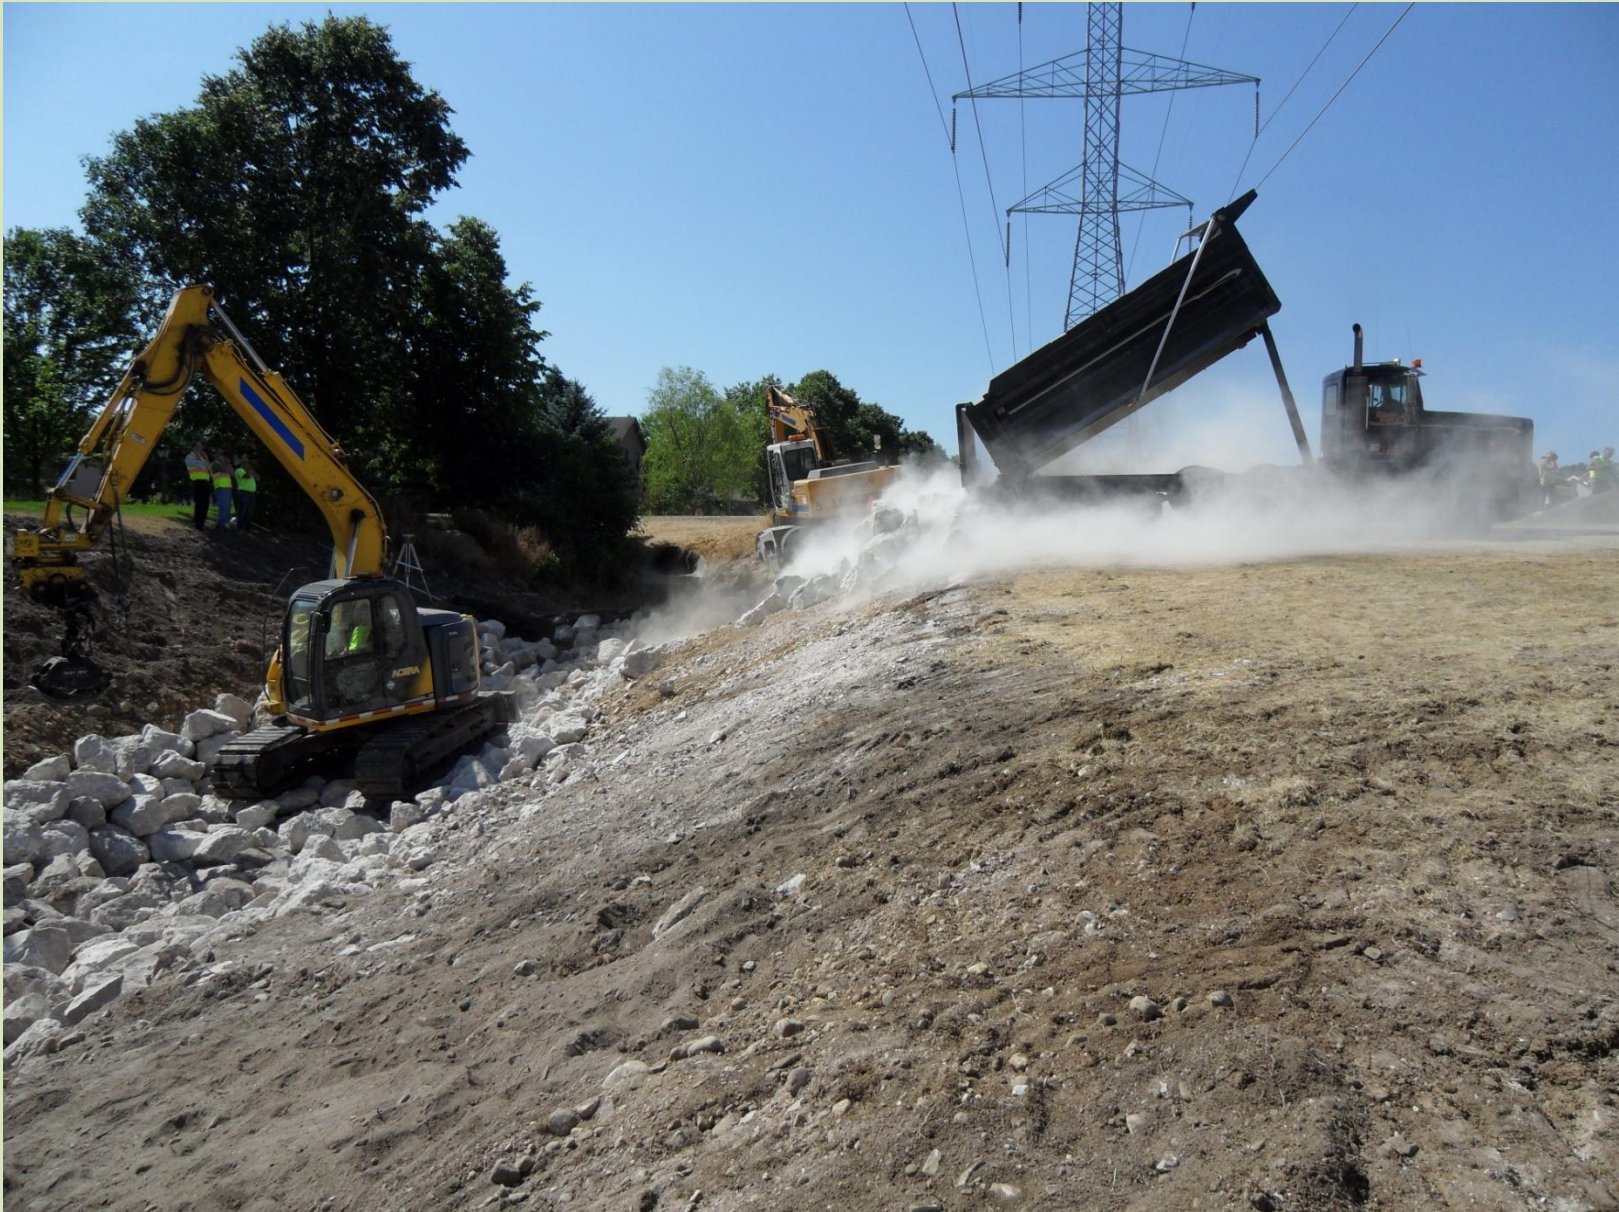
Lining Stilling Basin

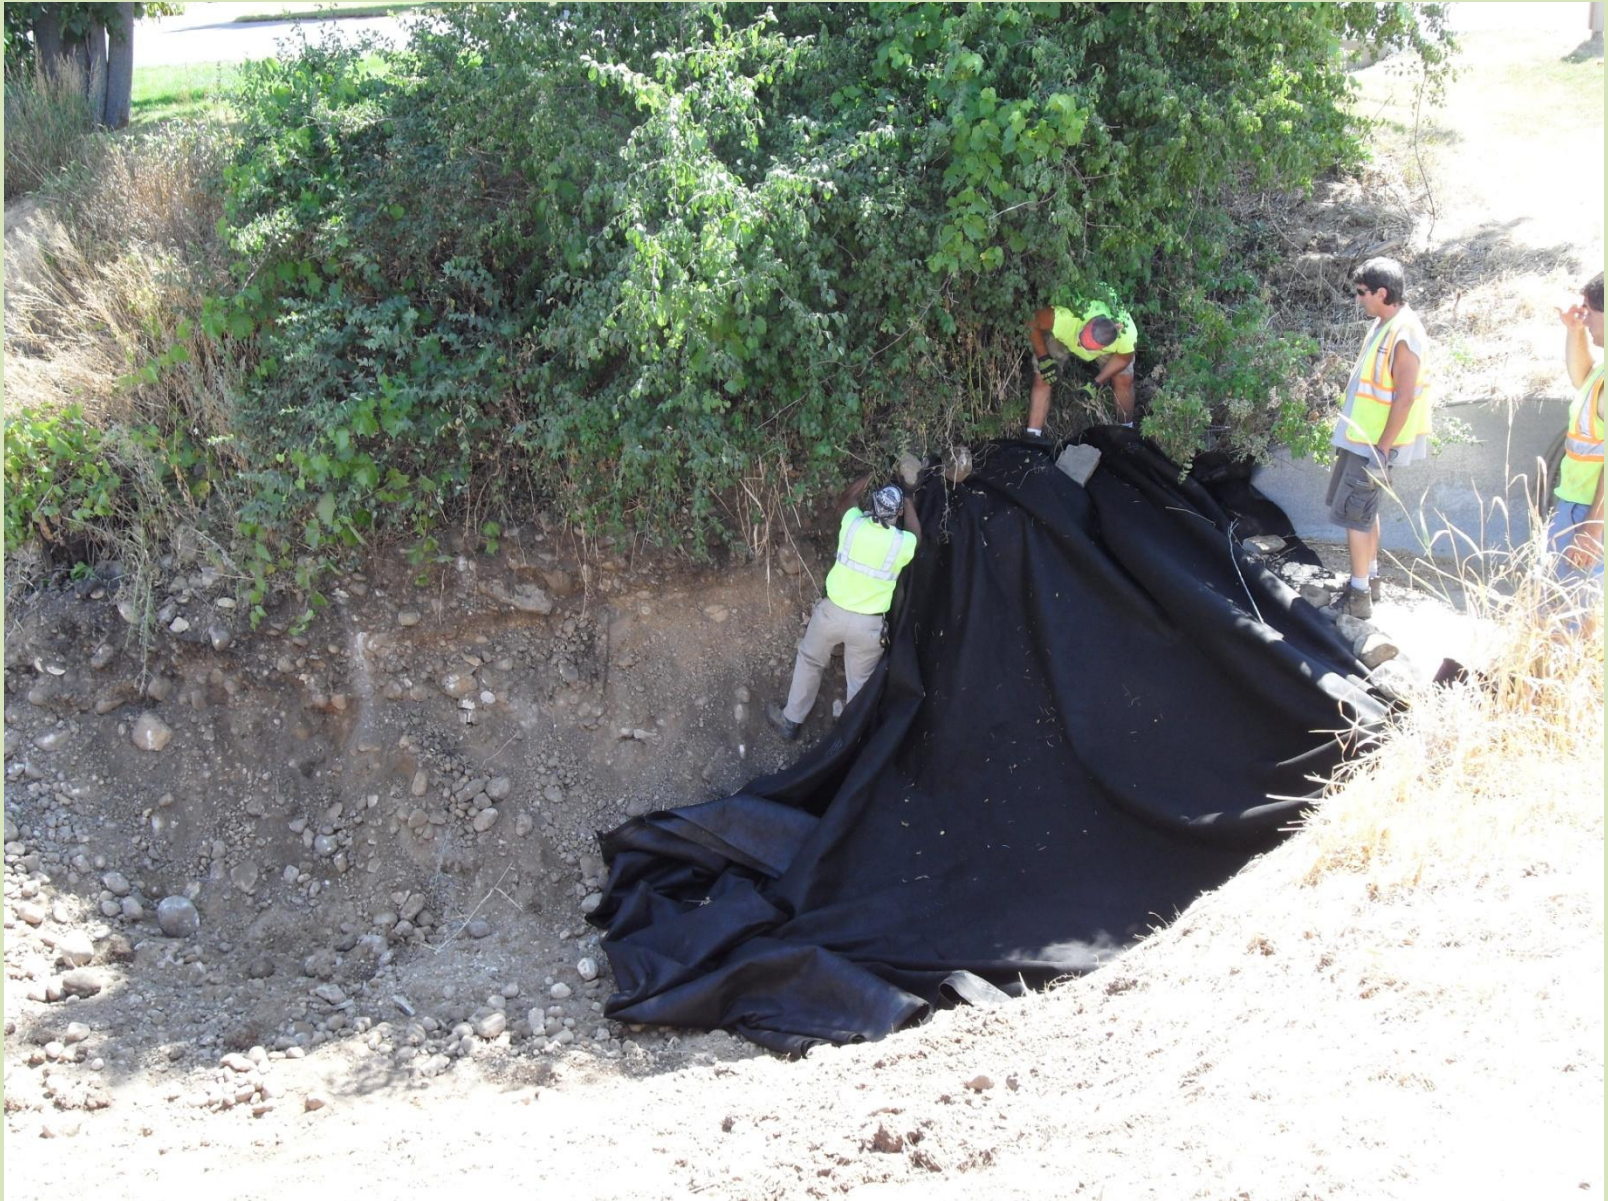
Fitting Riprap Together

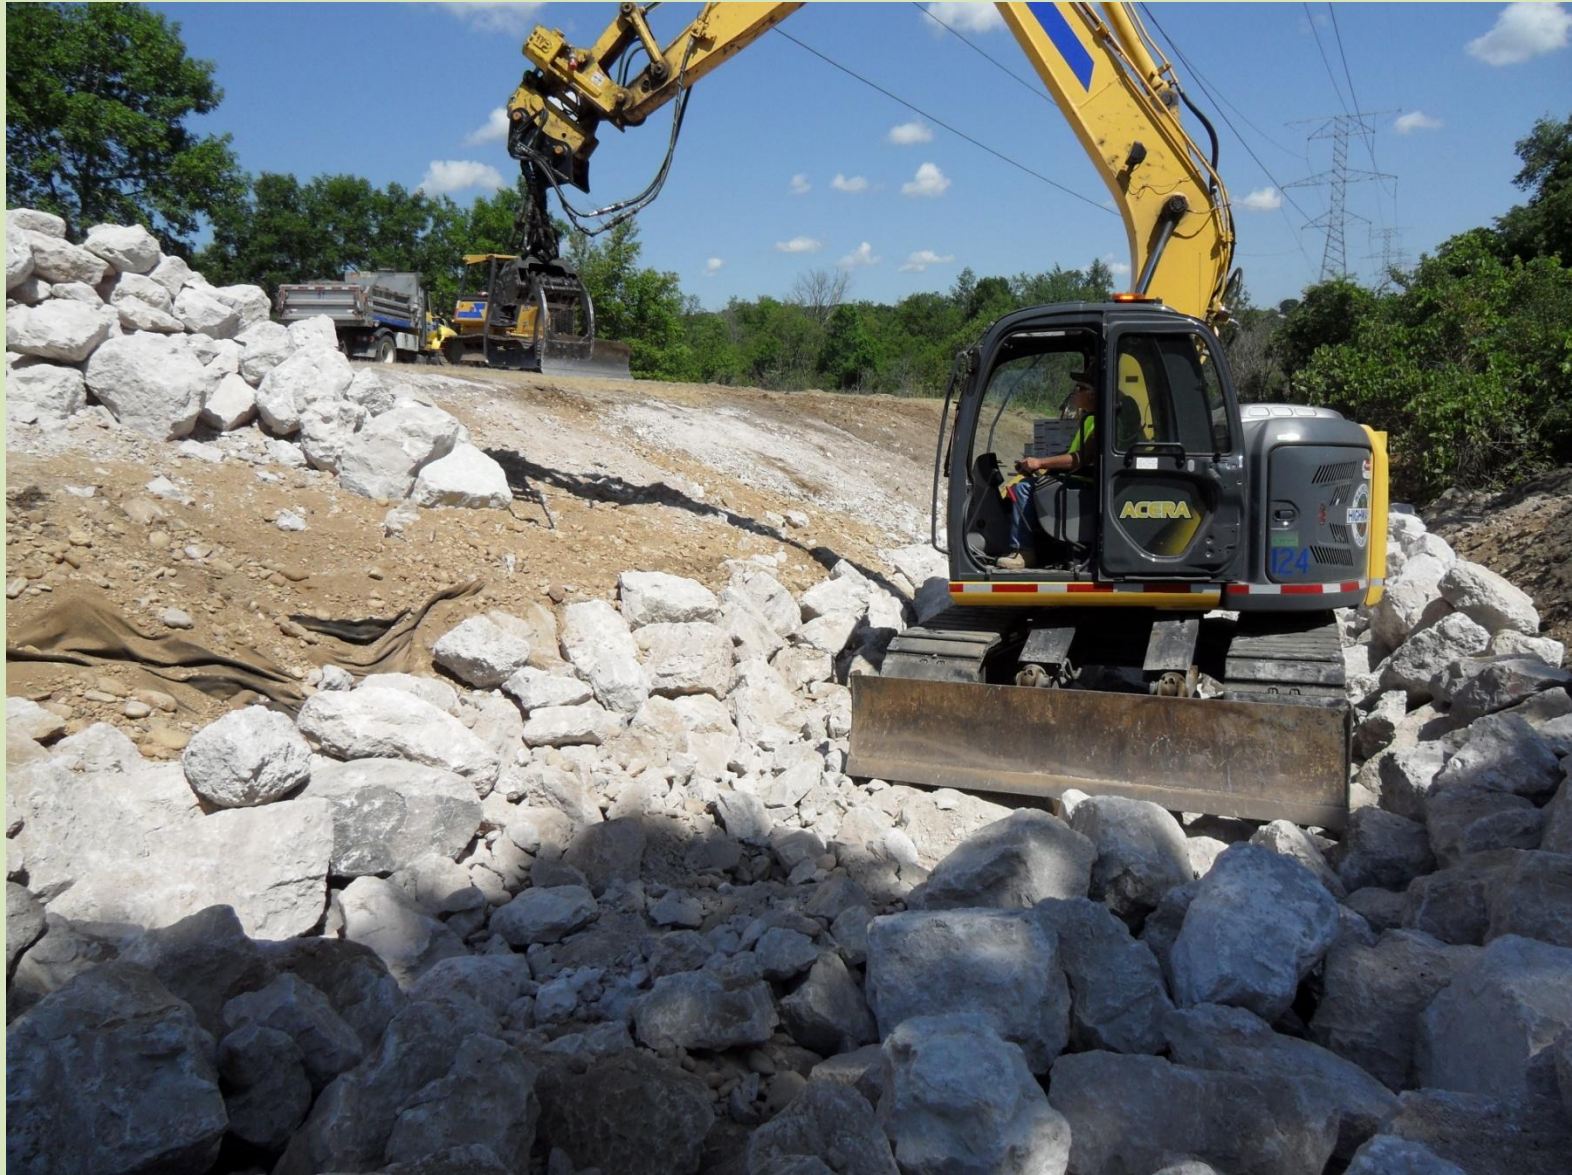
Riprap in Stilling Basin

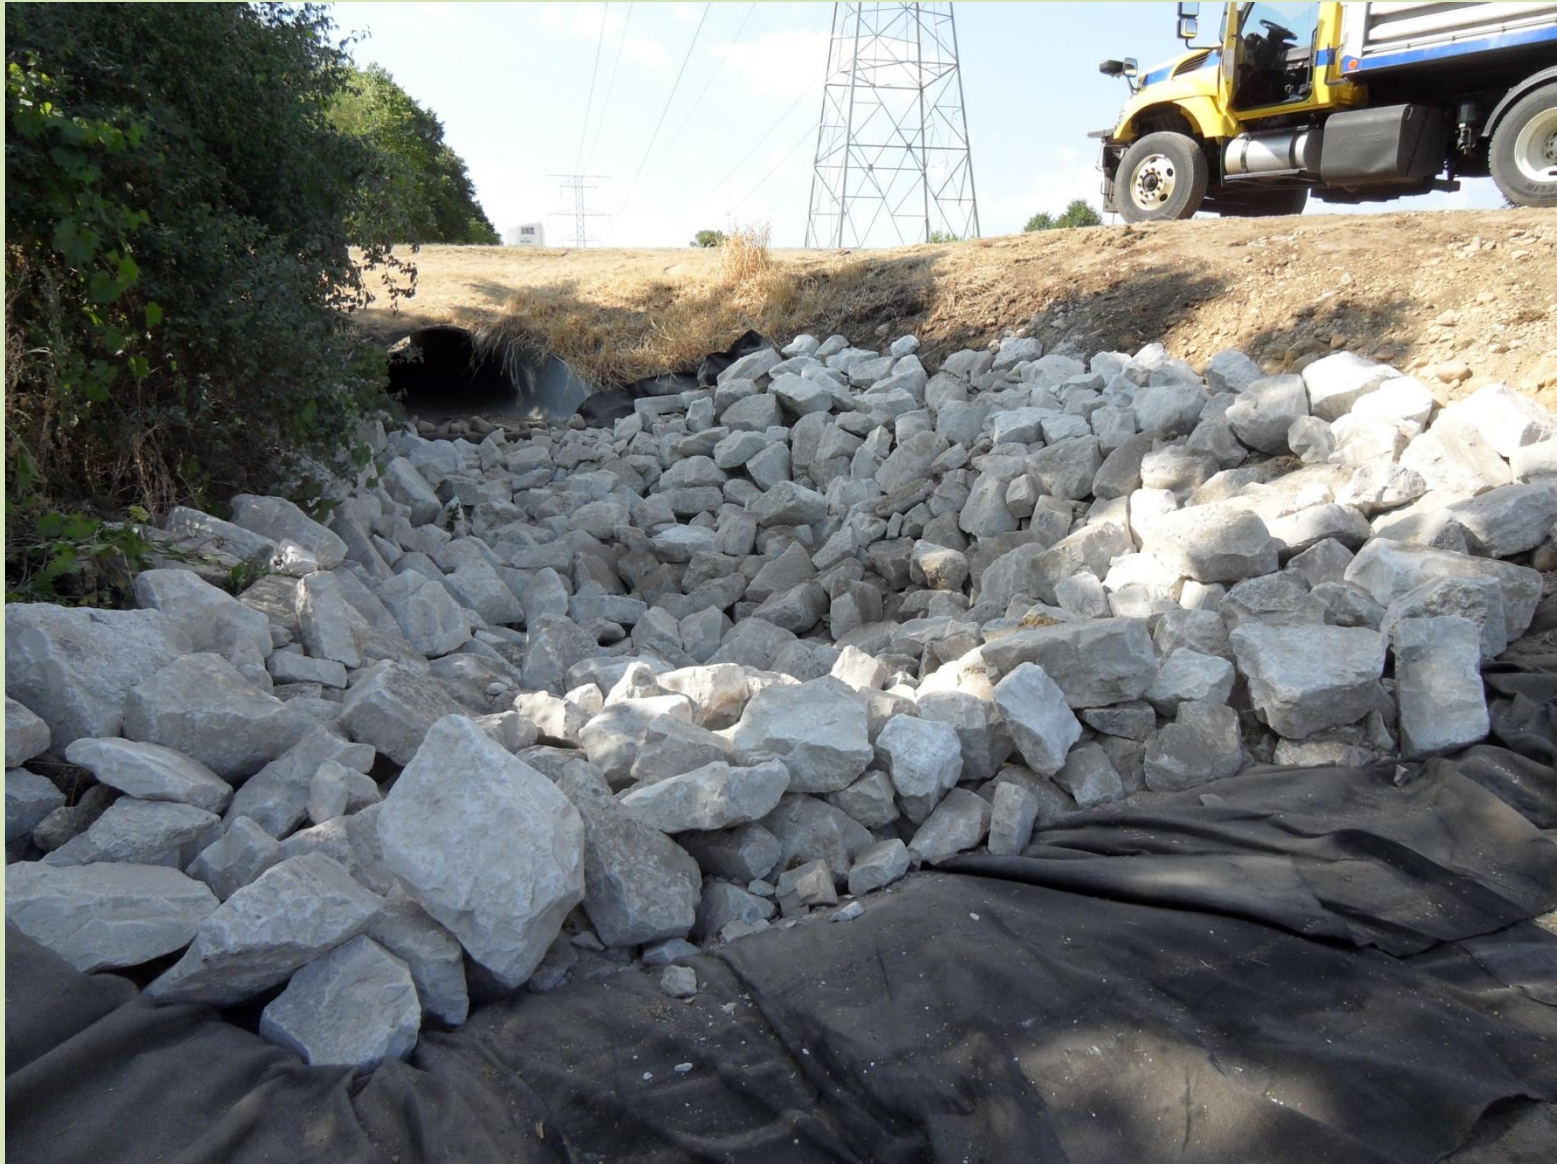
Materials for Vegetated Retaining Wall

Sandbags, Polymer, Prairie Seed, Temp Seed, Wood fiber, Net-Free Mat

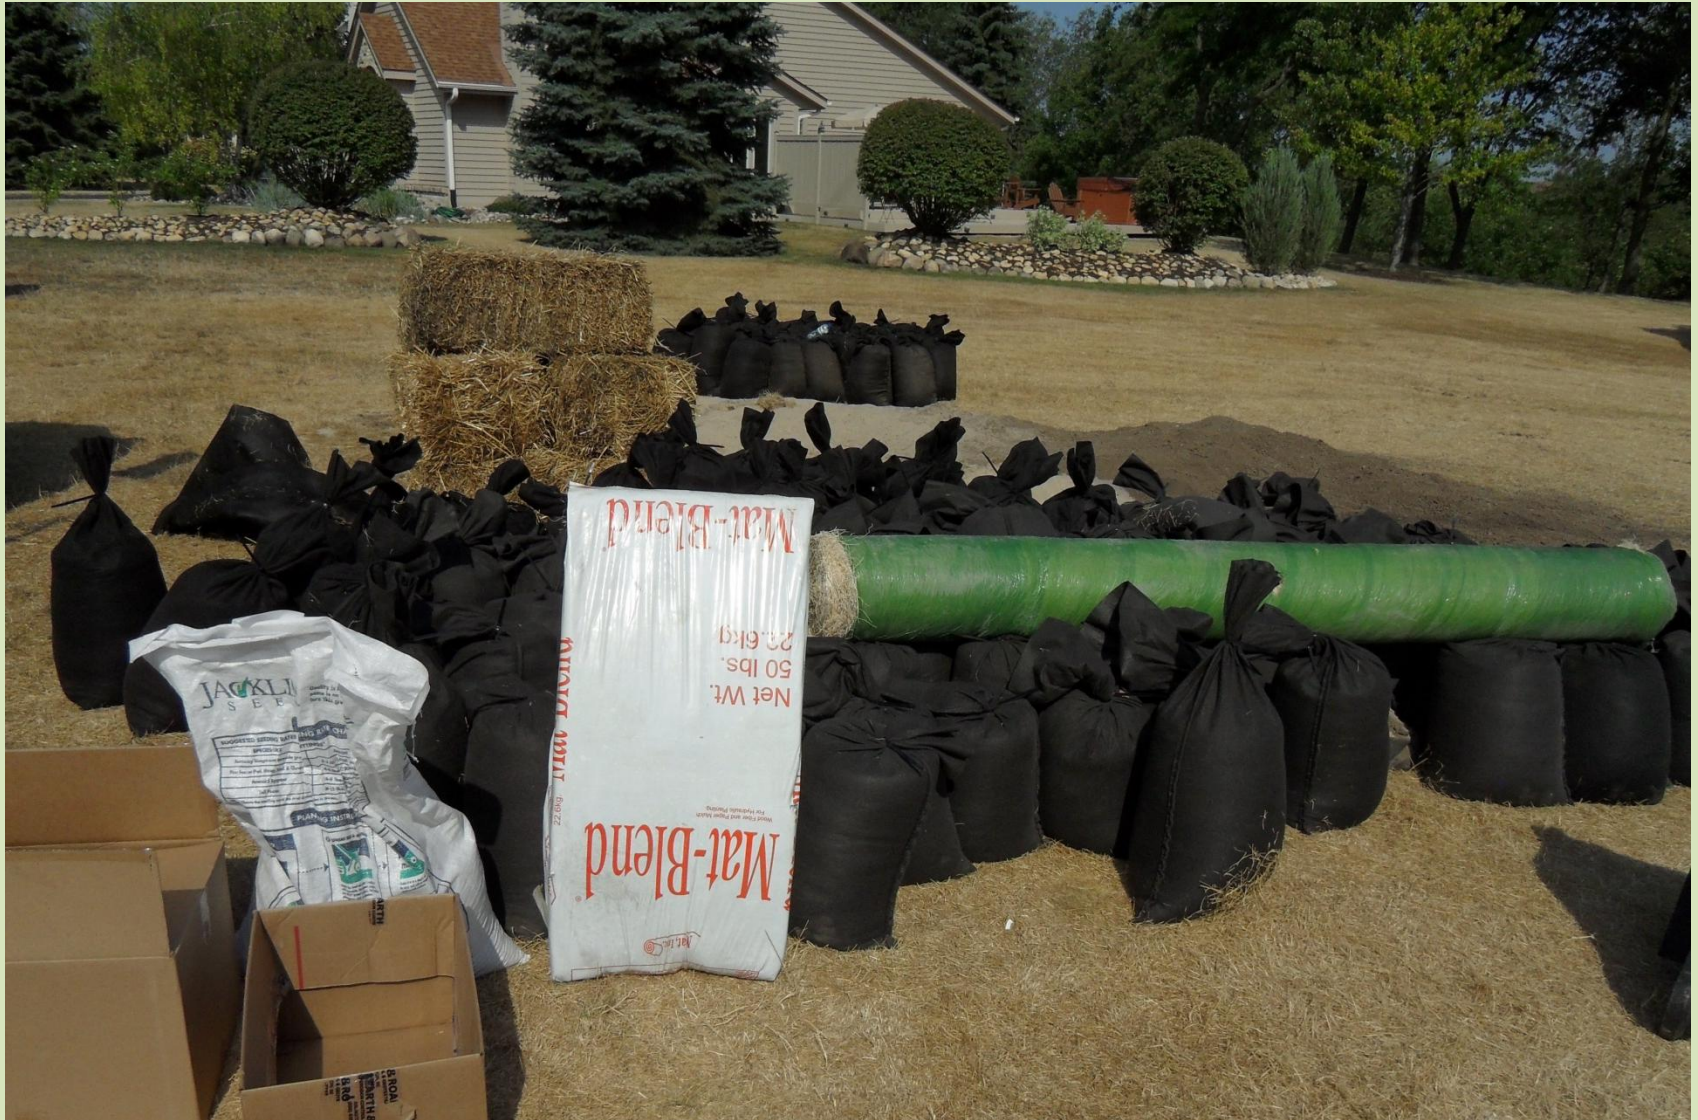
Filling Sandbags For Retaining Wall

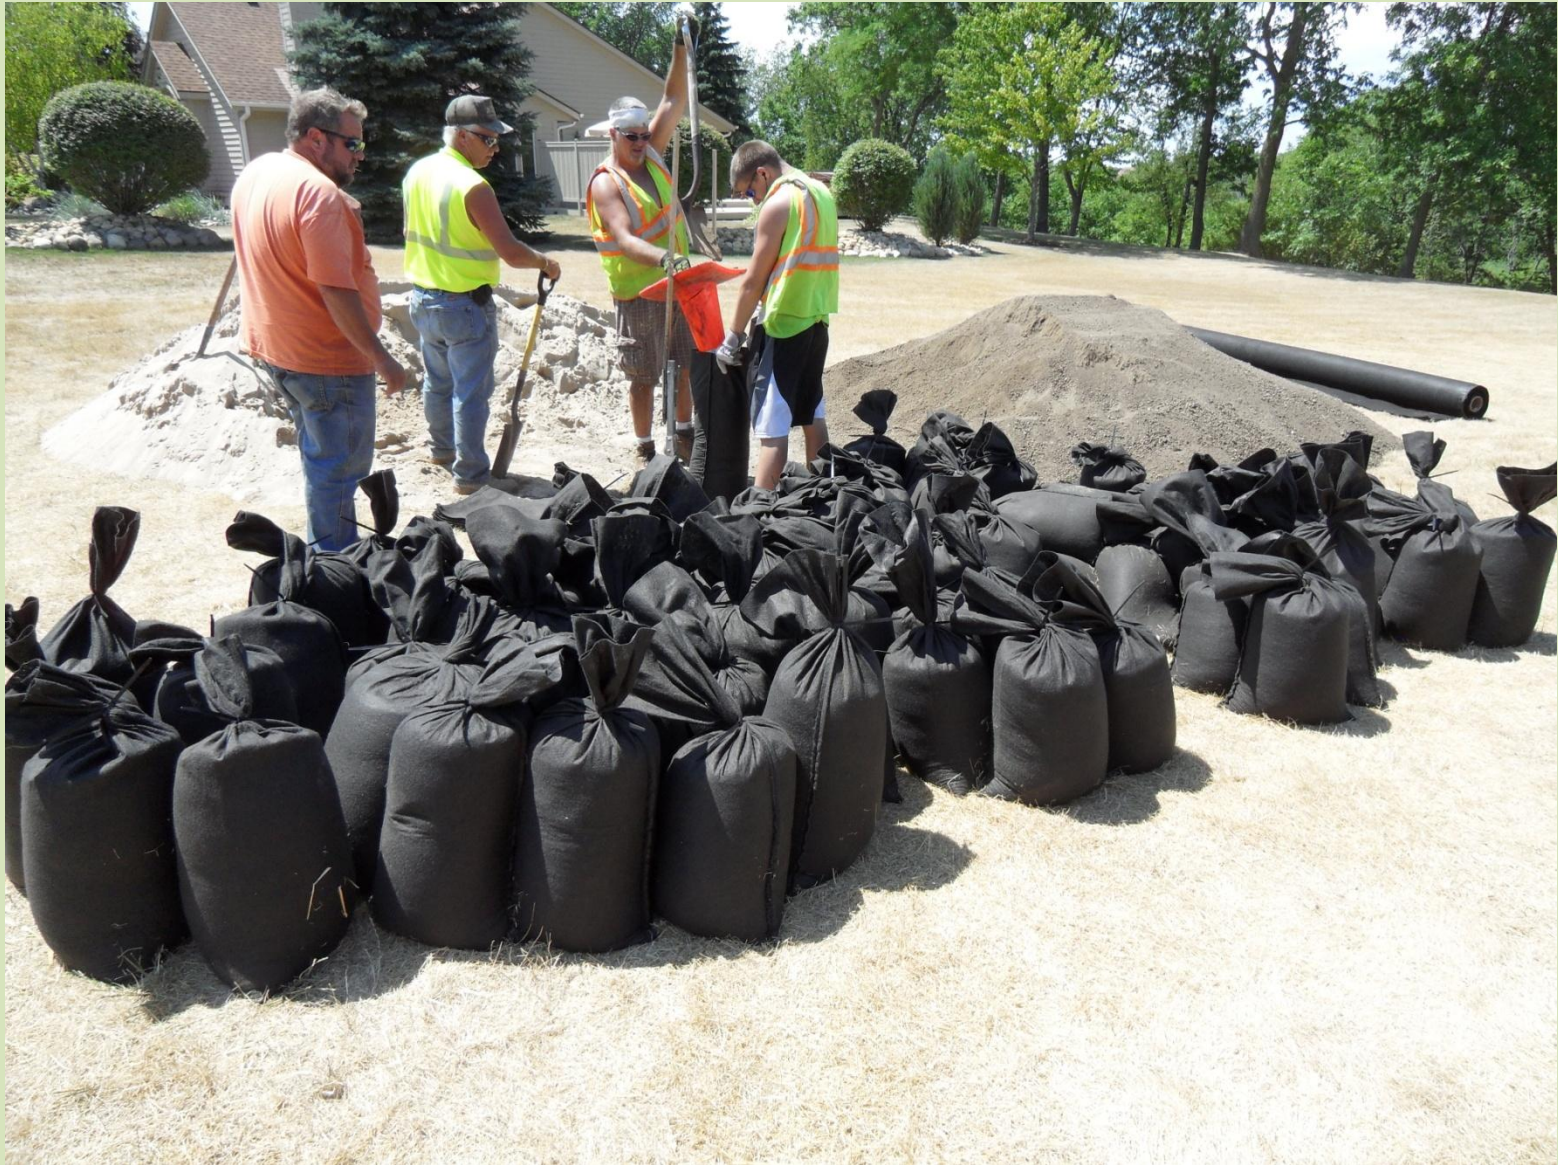
Spikes to Lock Bags Together
