Progress Report for SE WI Fox River Commission

Mill Creek Drainageway Improvement

Grading Drainageway, Erosion Control

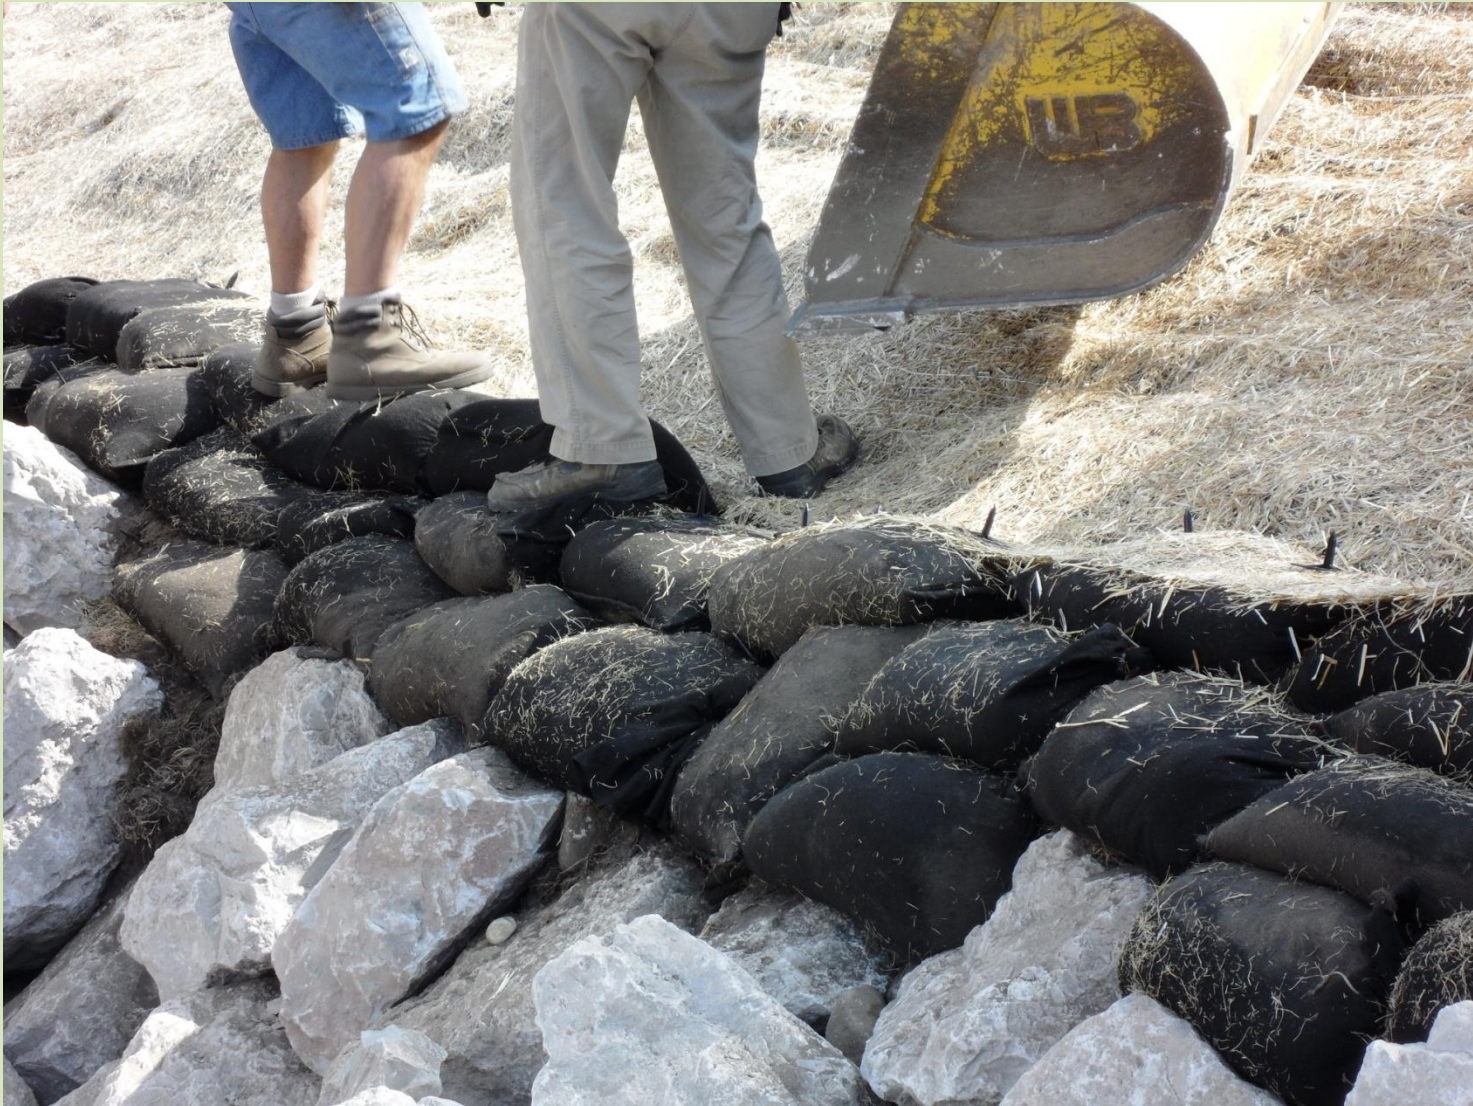
Transferring Sandbags Across Drainageway

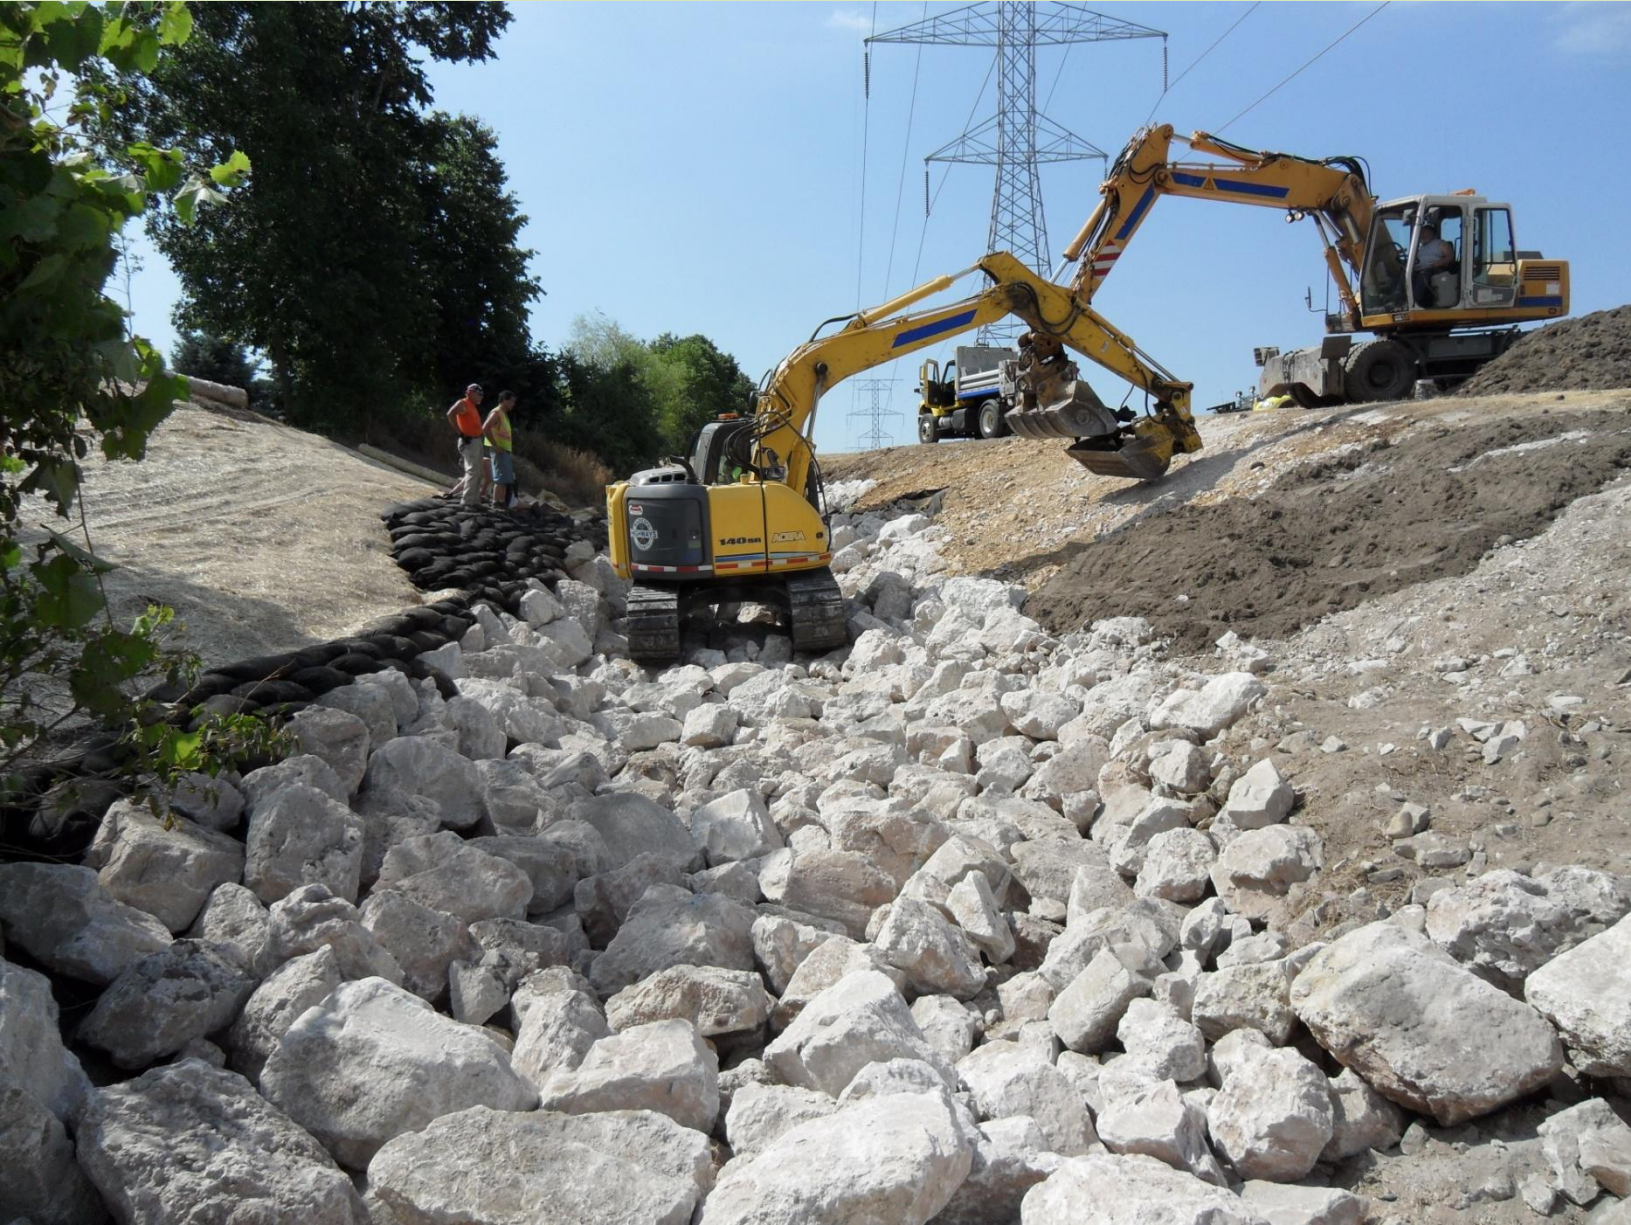
Completing Sandbag Placement

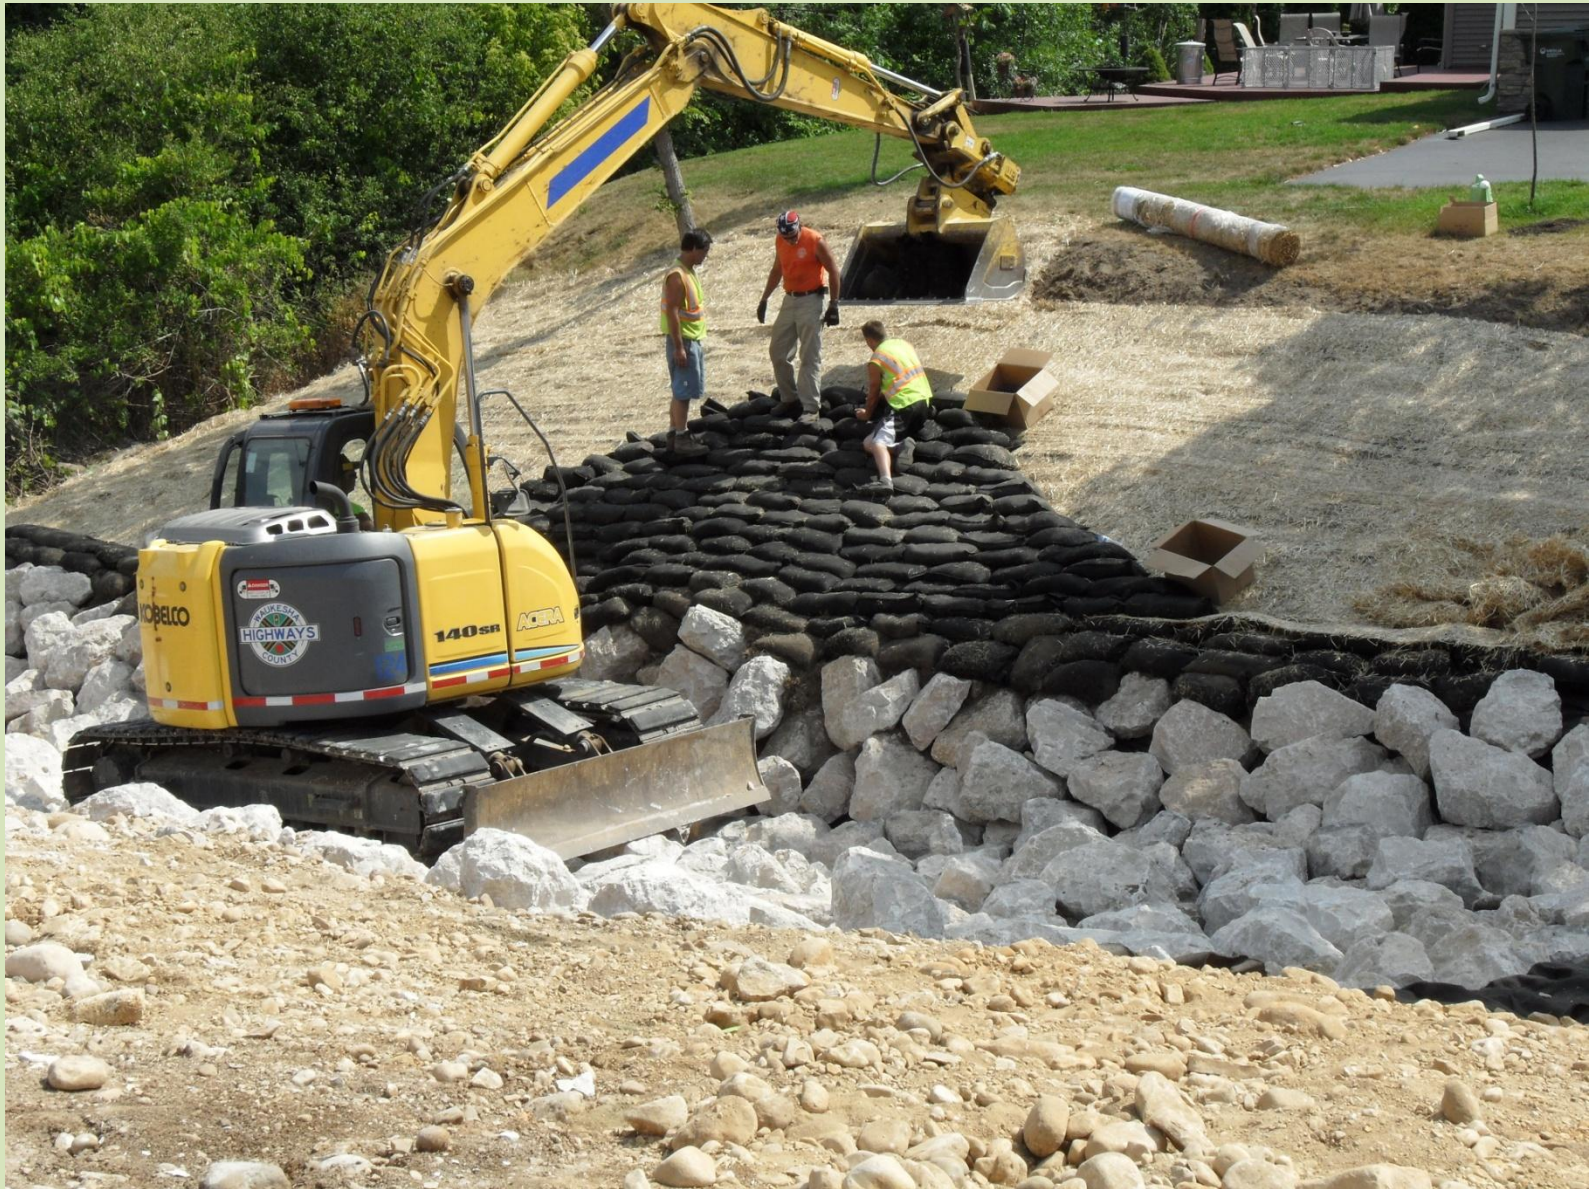
Mixing Seed Slurry to Cover Retaining Wall

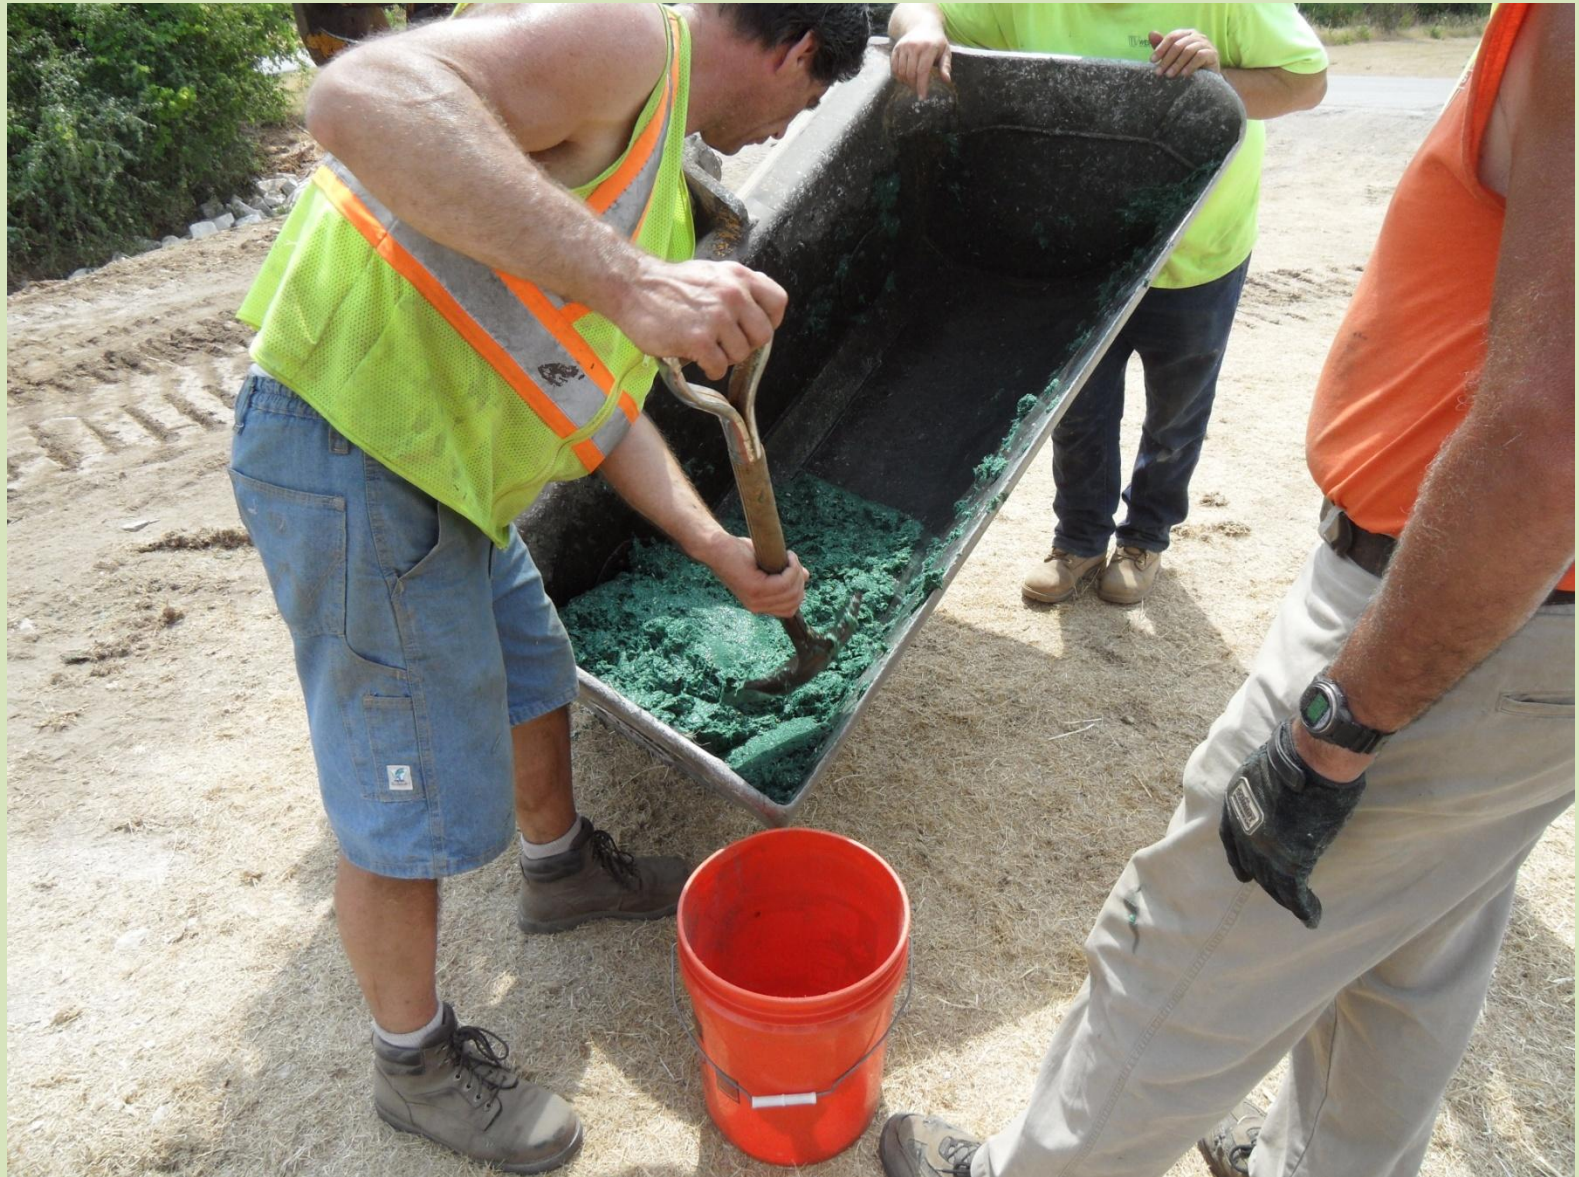
Covering Sandbags with Seed Slurry

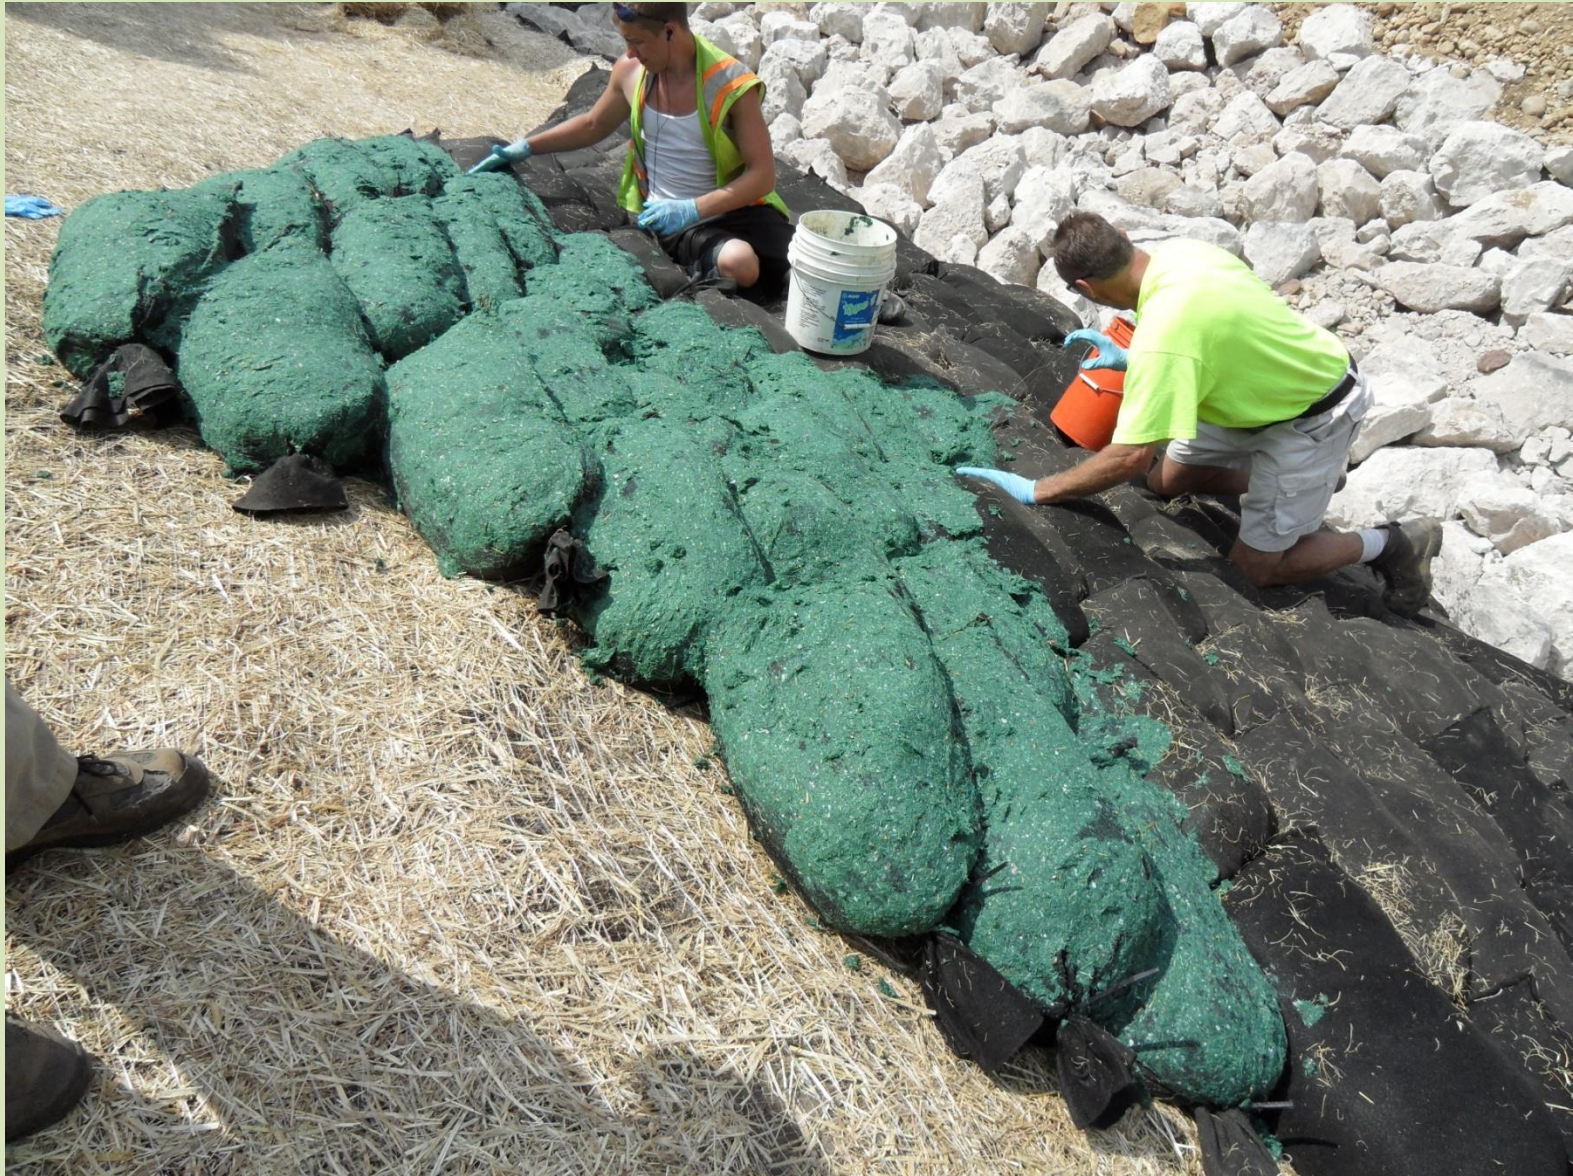
Covering Retaining Wall With Net-Free Wood Fiber Blanket

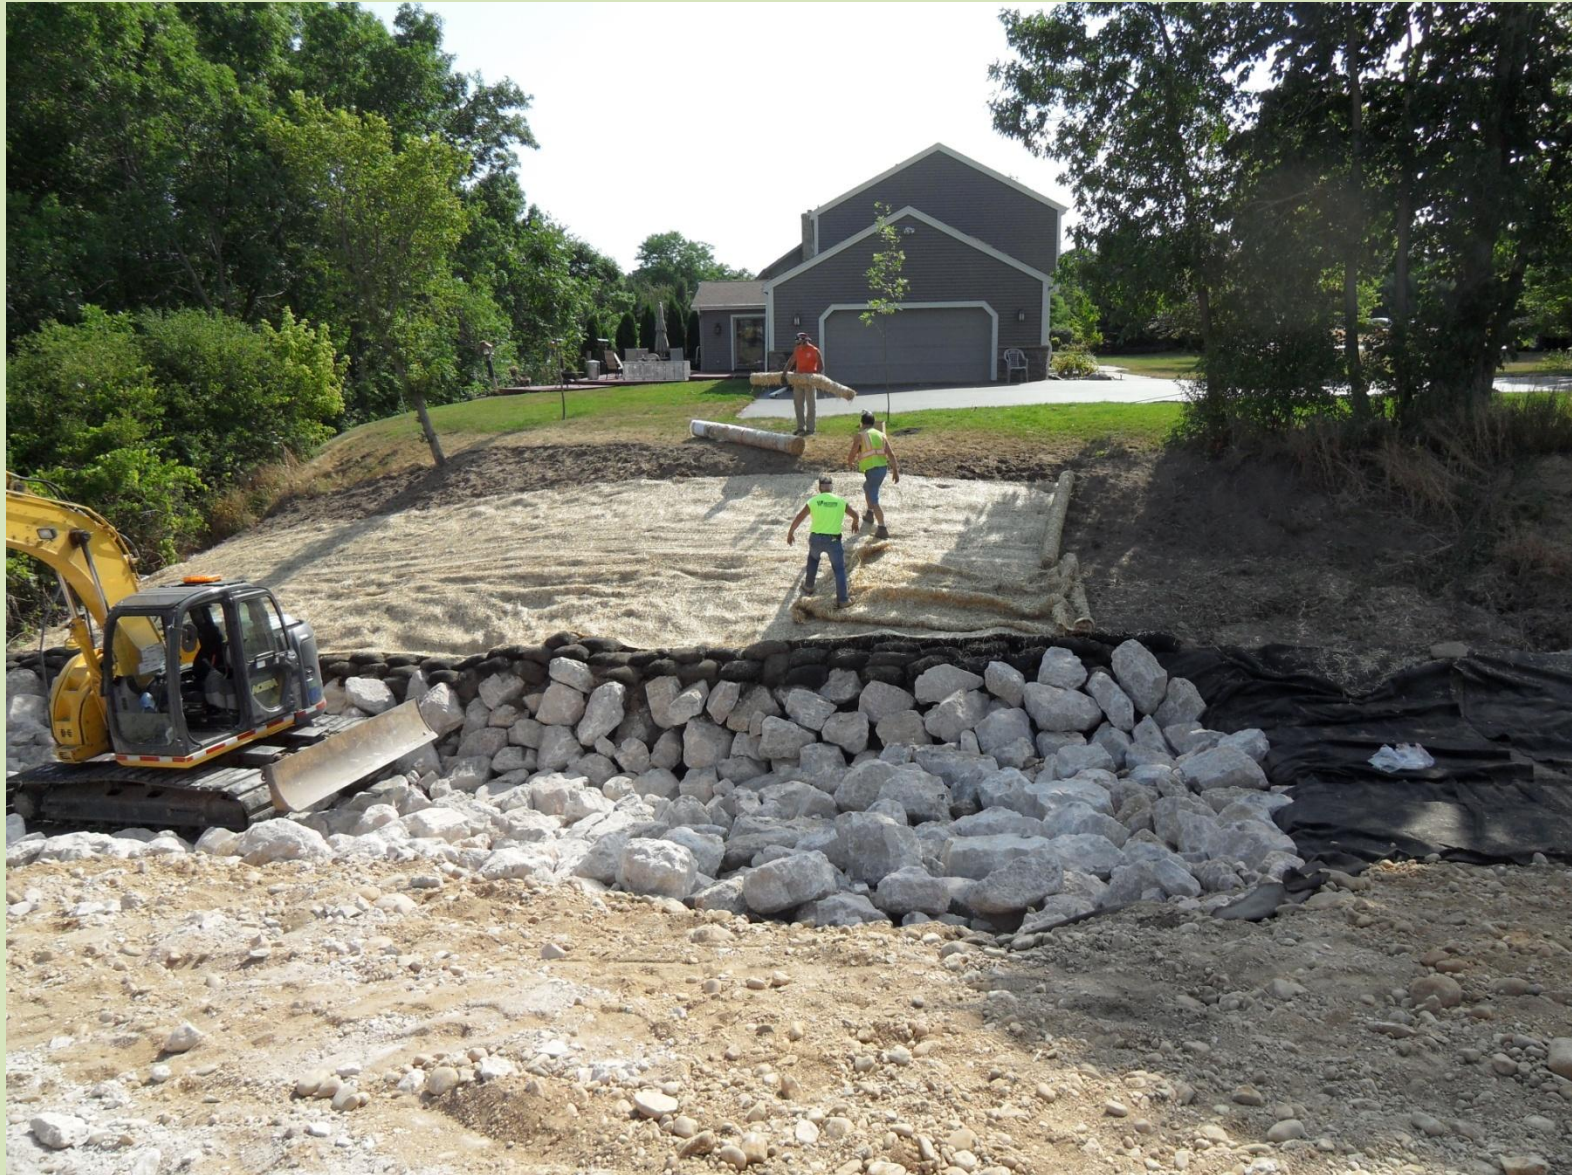
Stapling Erosion Control Matting

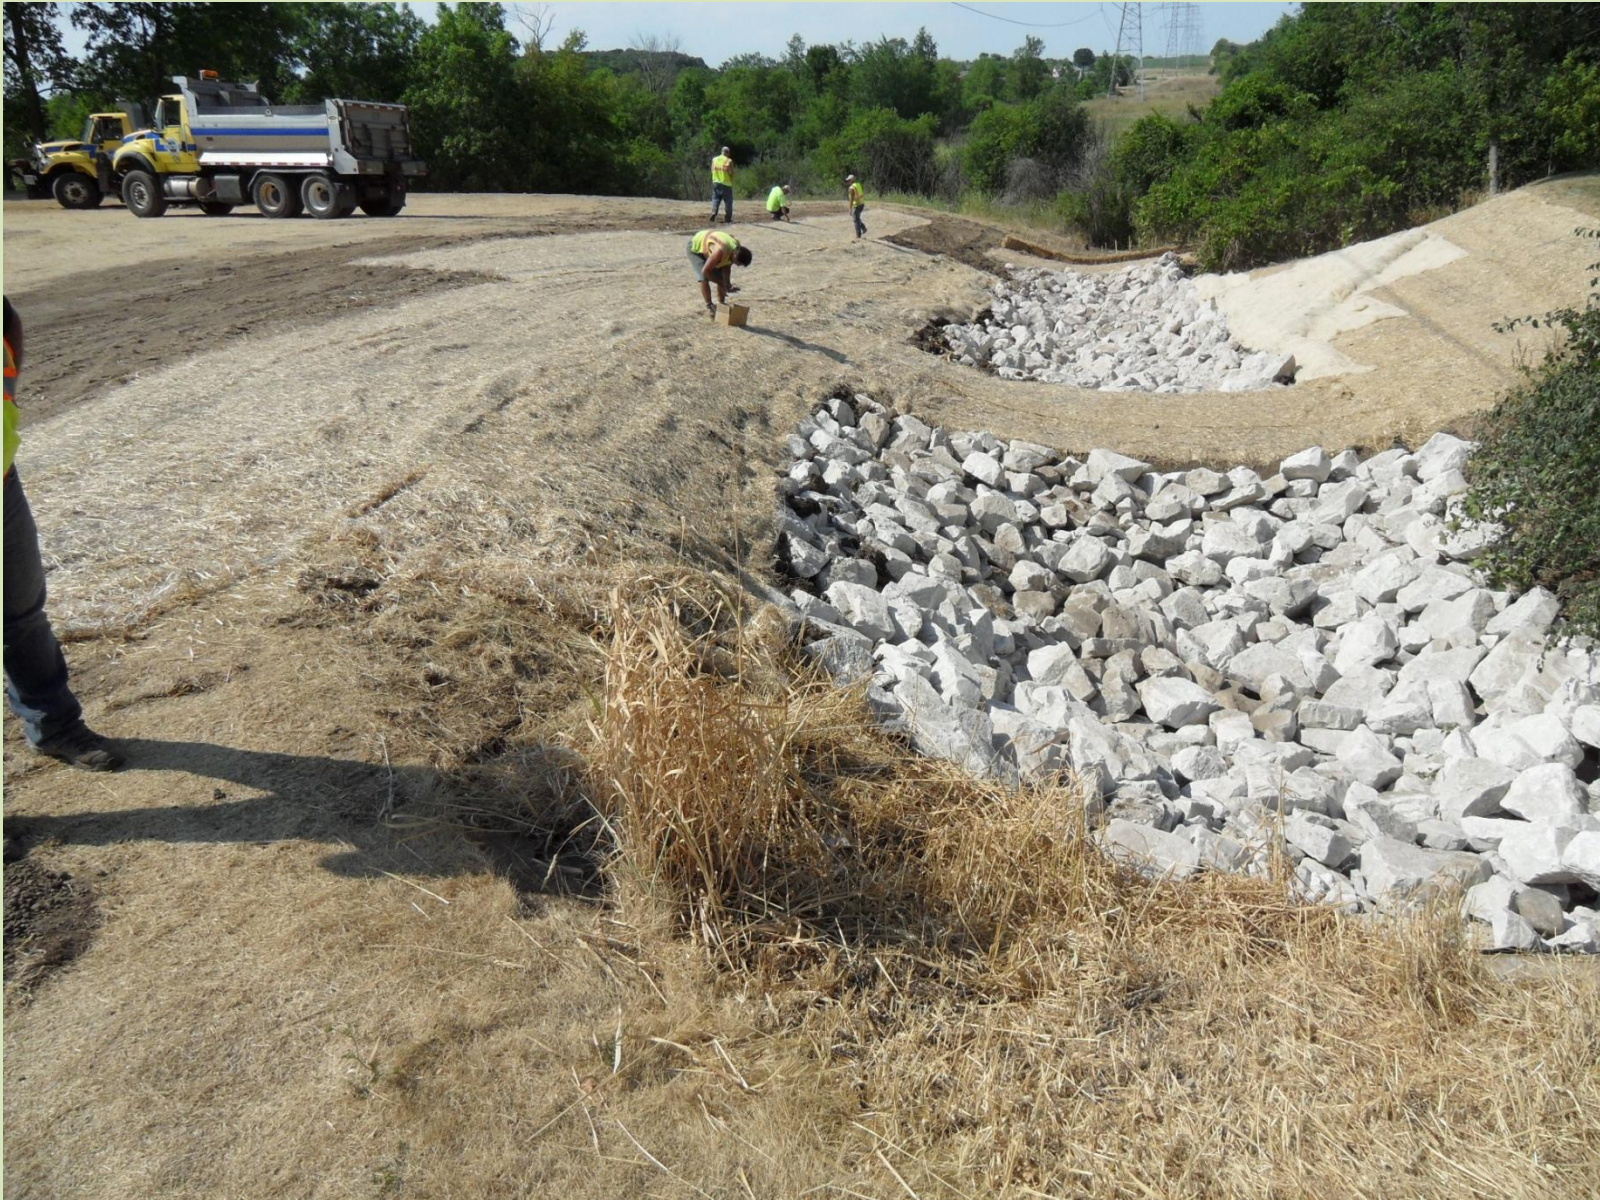
Irrigation Setup

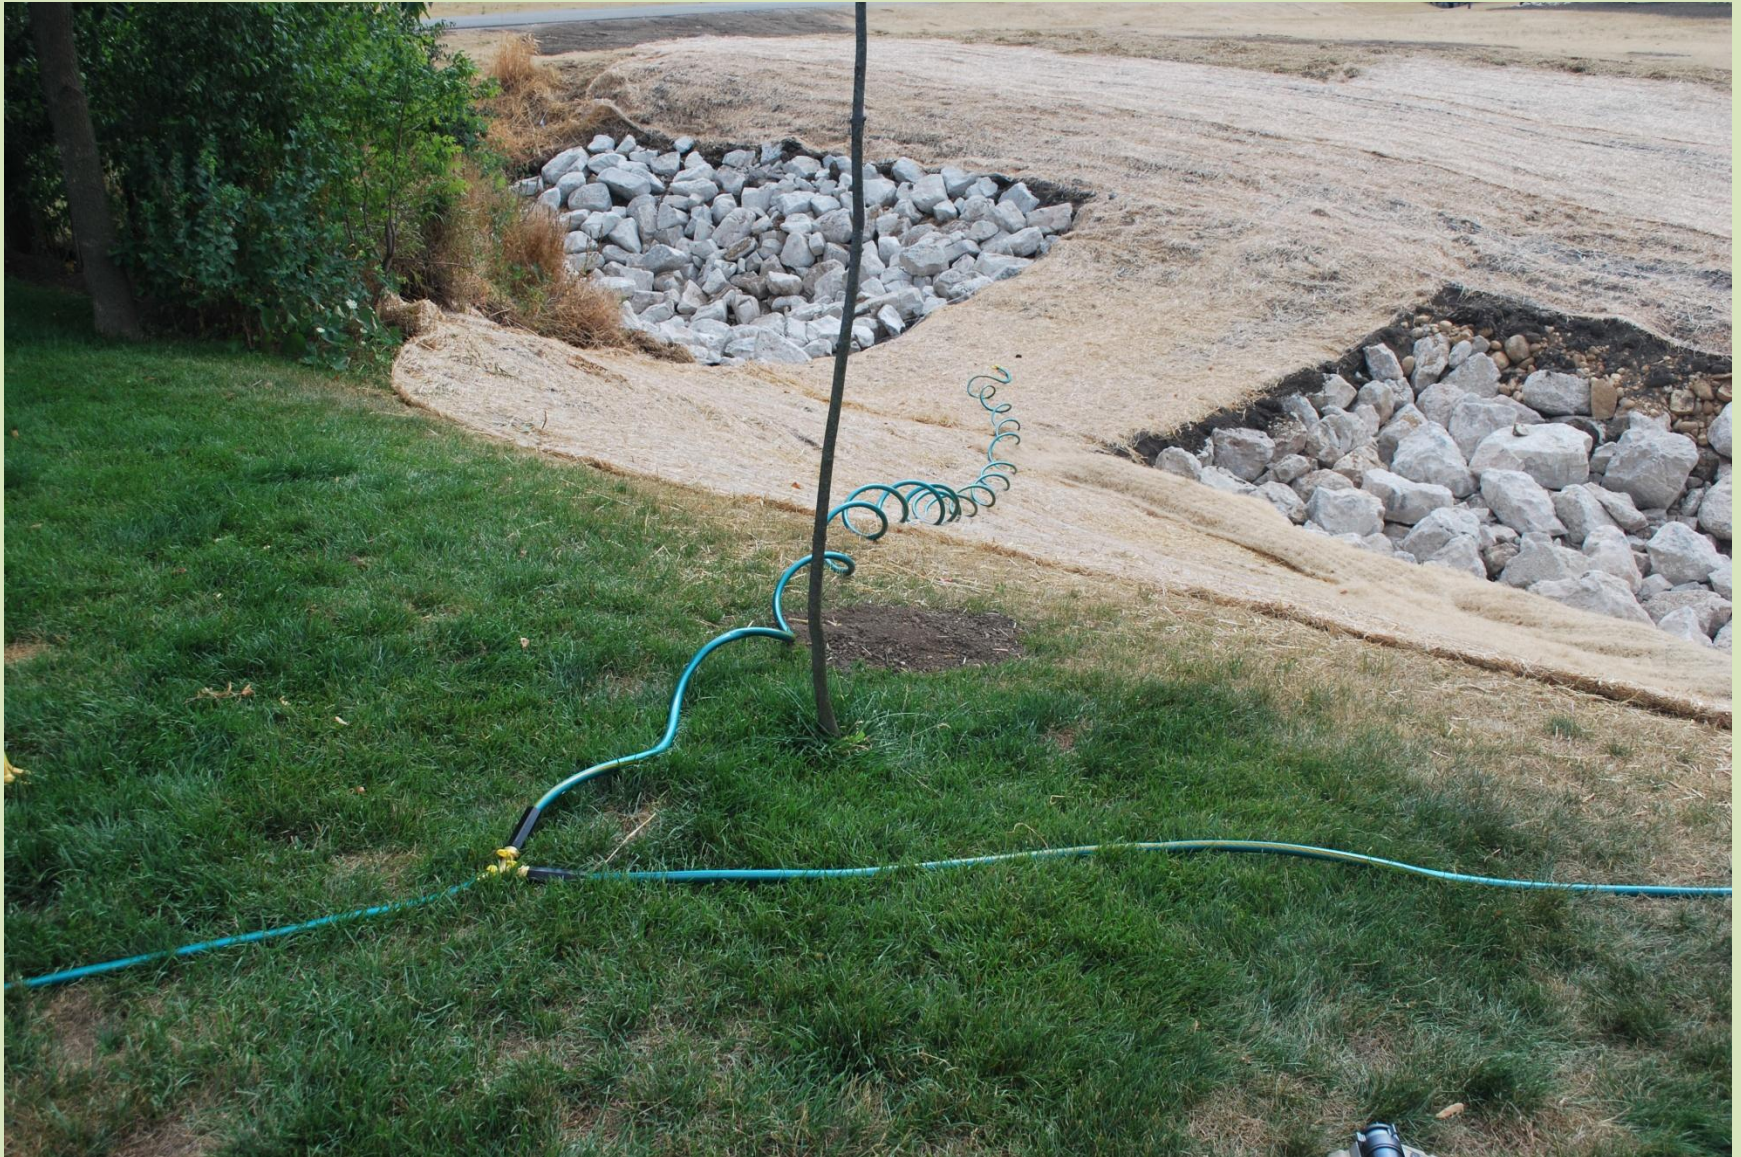
Grass Germinating After 1 ½ Weeks
